**The Coal  
Authority**

## **Site Inspection Report**

### **Pen y Graig Quarry, Ystalyfera**

**Date: January 2018**

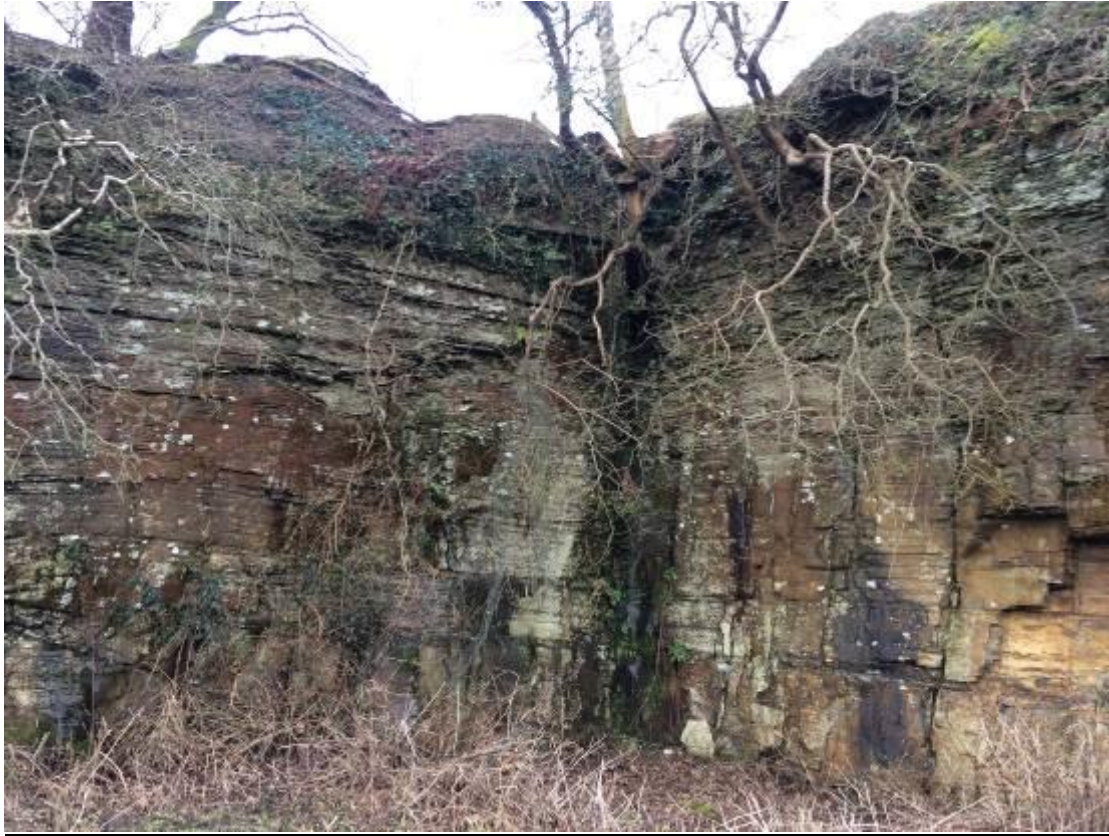
There was no evidence of significant loose or overhanging blocks other than areas where fallen trees have disturbed the strata. Numerous seepages were noted from the high wall face, generally at the interface of sandstone / siltstone units (Photograph 3). An area of uprooted and fallen trees was observed at the mid-point just below the crest (Photograph 6). These features were observed during the previous inspection and have not altered significantly.

**Photograph 3 – Quarry high wall showing seepages**

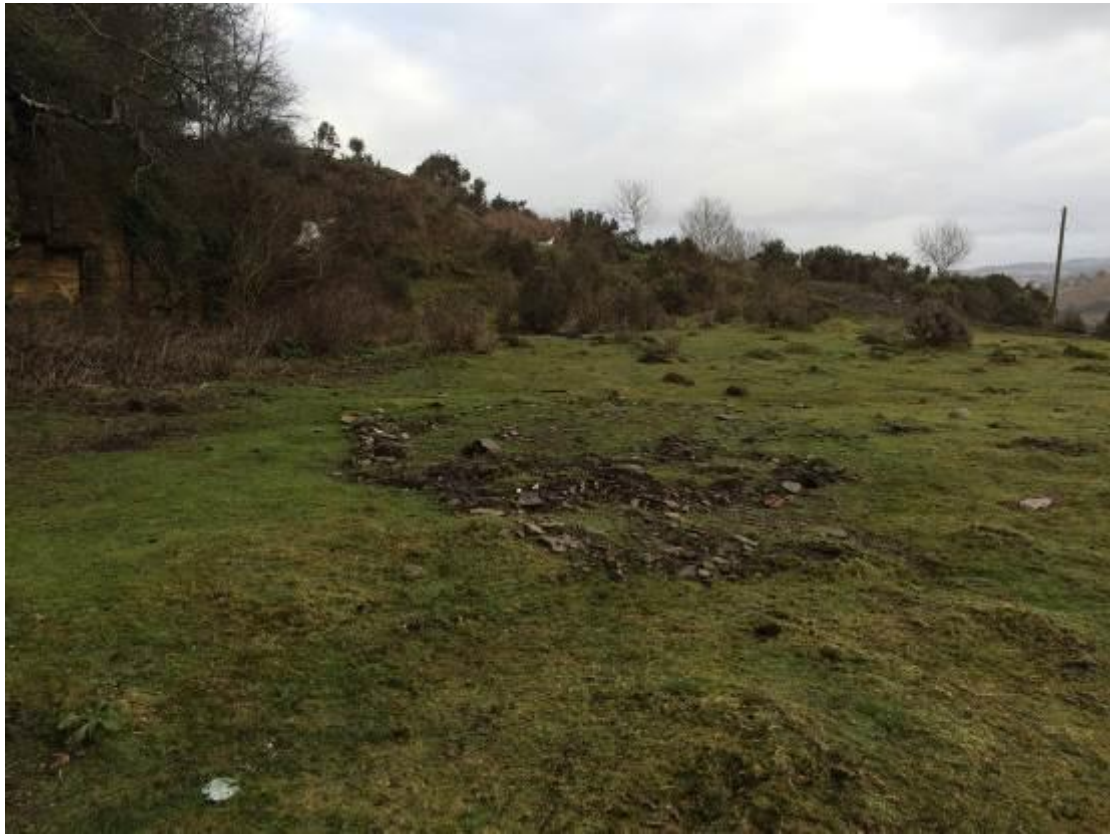
A borehole has recently been sunk in the quarry floor, with a remote data logging apparatus evident at surface. It appears that other ground investigation works (trial pits) have been undertaken within the quarry floor as evidenced by areas of disturbed ground (Photographs 5 & 11).

**Photograph 5 – Ground disturbance from recent investigation works**

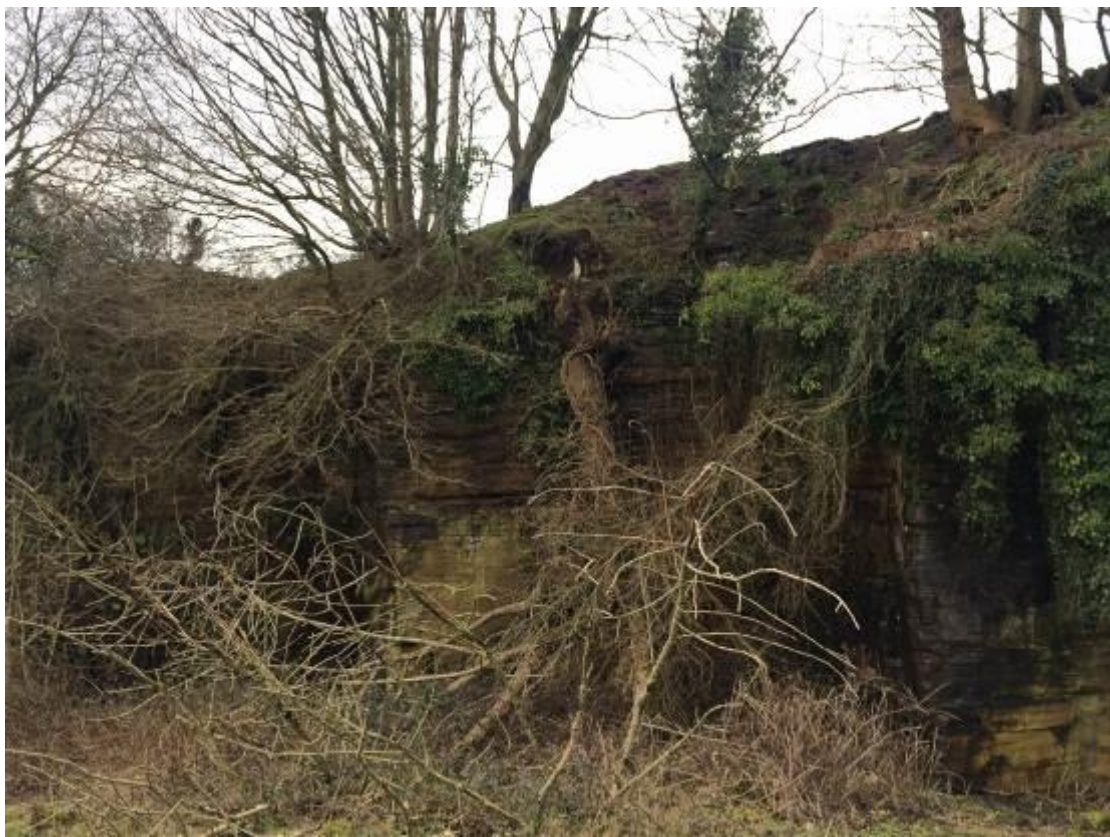
**Photograph 6 – Fallen trees at crest of high wall**

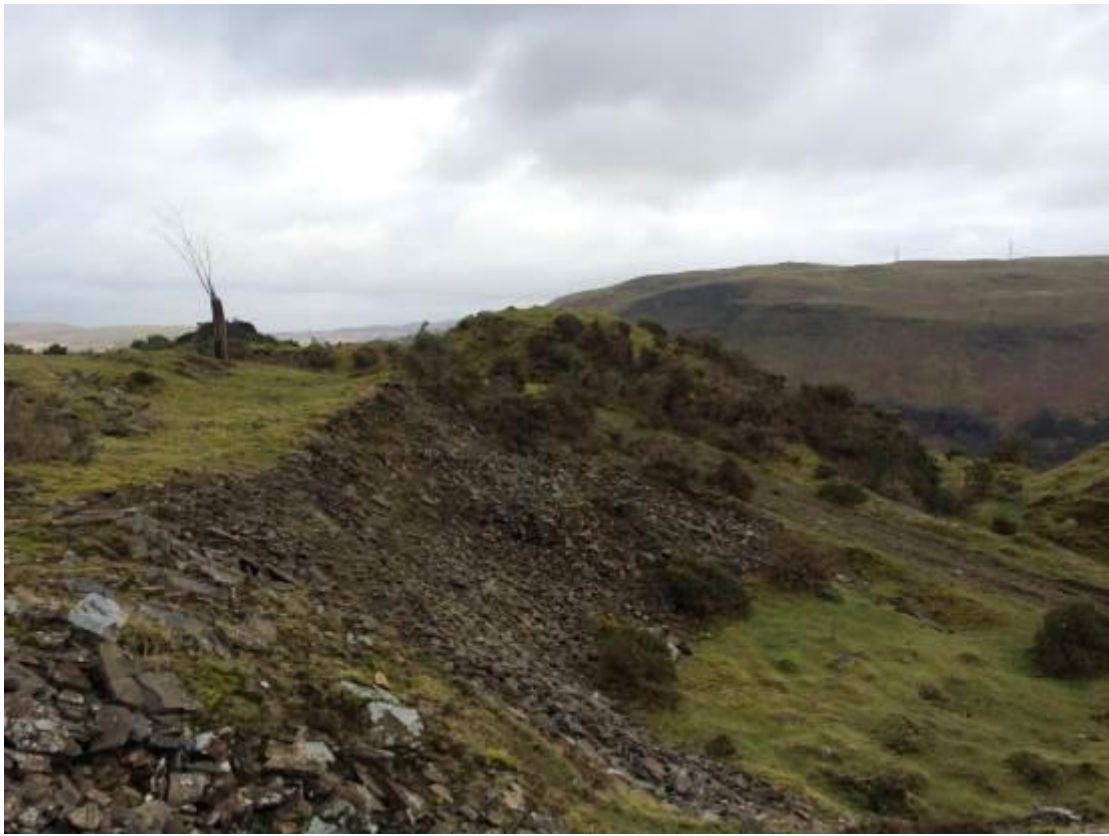
**Photograph 10 – Bare spoil mounds at northern edge perimeter of site**

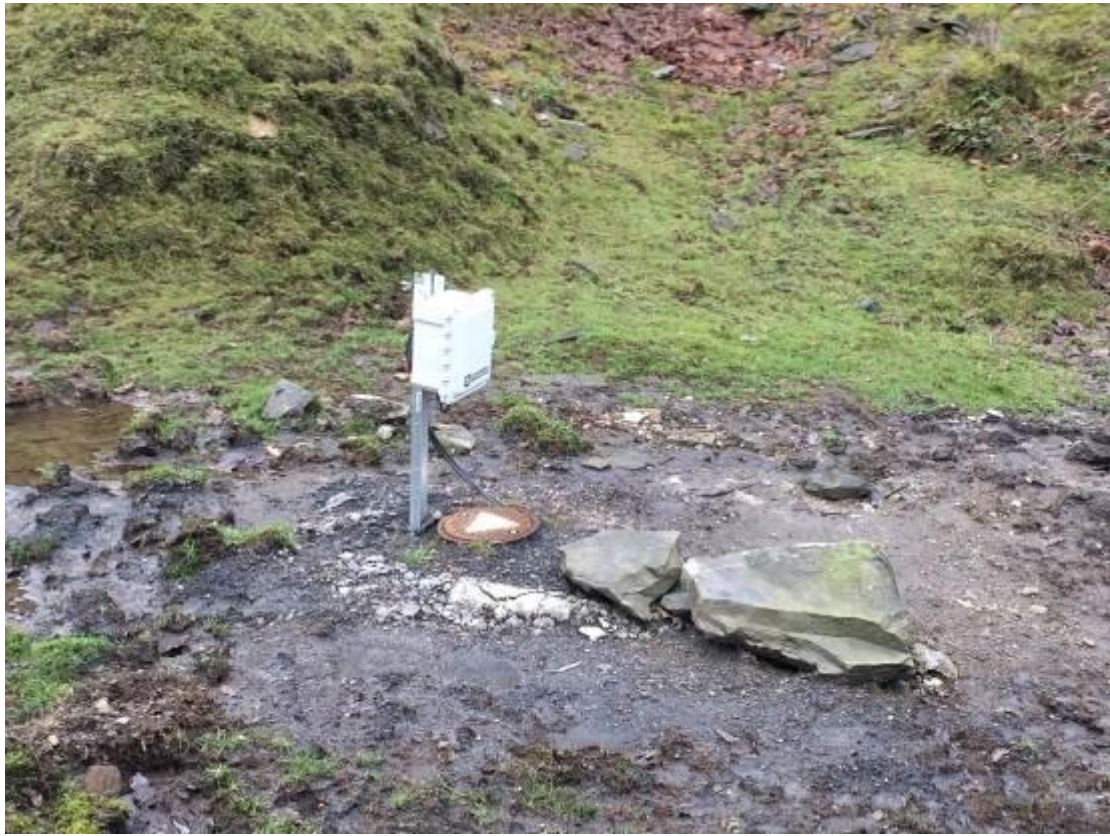
**Photograph 11 – Recently installed borehole and data logger installation**

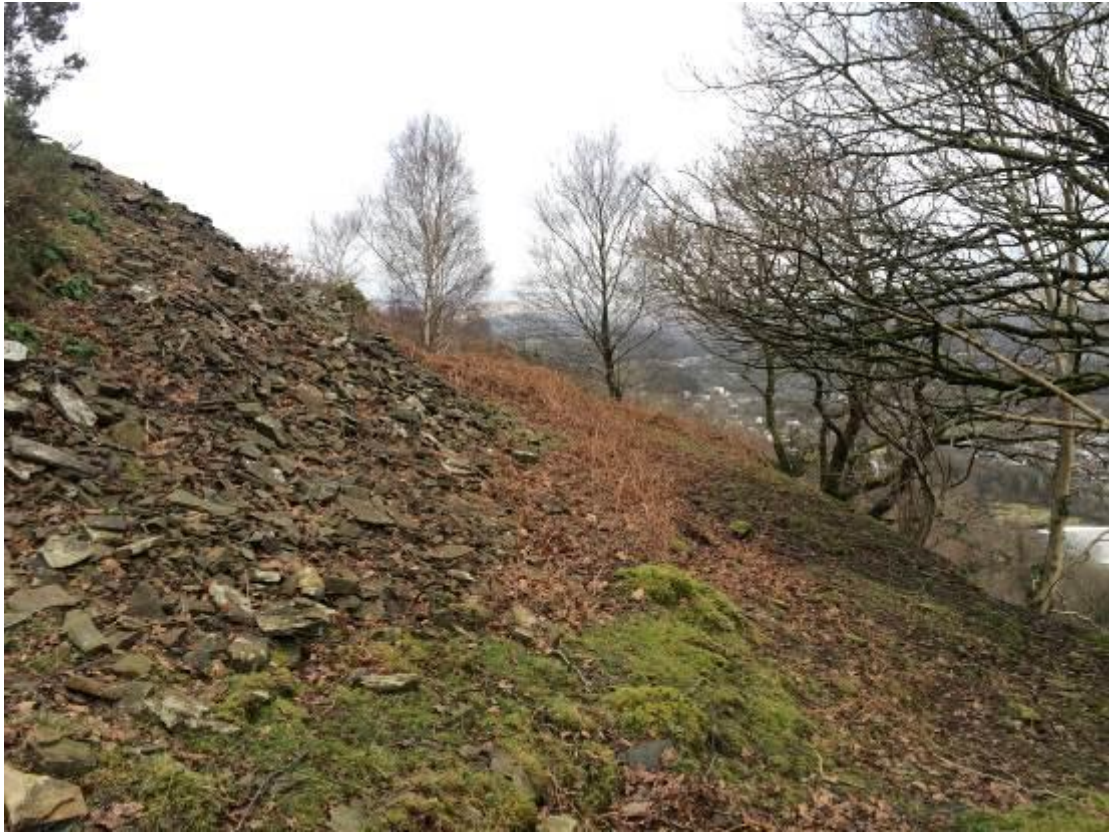
**Photograph 13 – Toe of spoil mound along cliff edge**

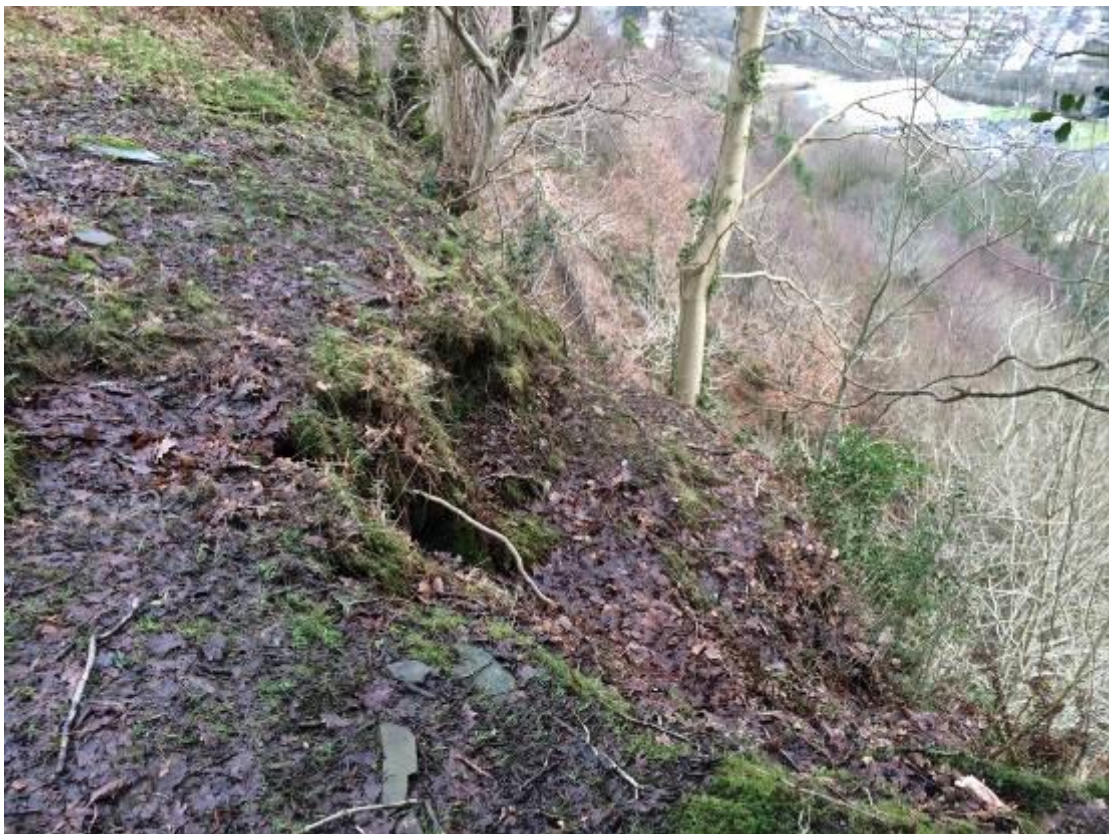
Following recent vegetation clearance, a small shallow circular slip was evident at the south east corner, at the crest of the cliff face (Photographs 14 & 15). The slip appears to be fresh and is likely to be a consequence of surface water flows emanating from the toe of the adjacent rock tip. A minor flow of water from the toe was evident during inspection.

Localised spalling and surface erosion of the bare spoil mound sections adjacent the cliff edge may result in small amounts of spoil escaping over the cliff edge during extreme weather events. As described above, there was visual evidence of slumping at the south east corner at the crest of the cliff edge to support this scenario.

**Photograph 14 – Minor slumping at crest of cliff to south east corner**

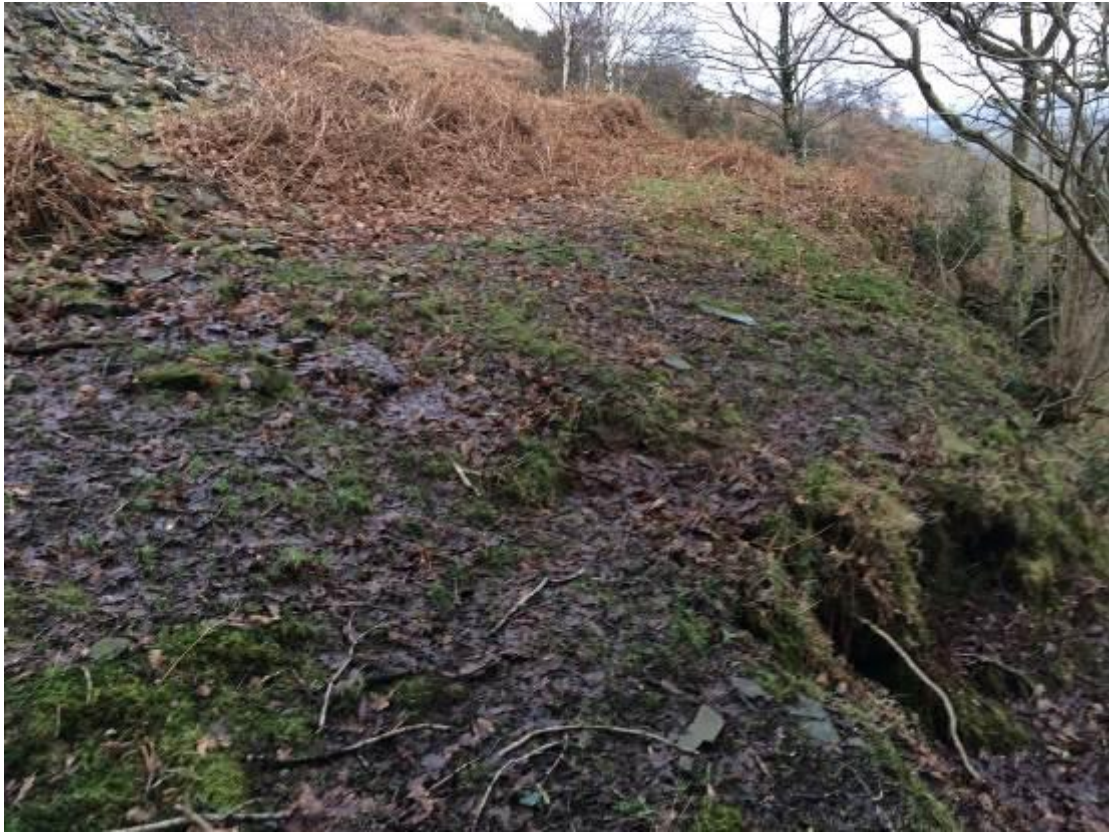
**Photograph 15 – Flow of water from toe causing cliff edge slumping**

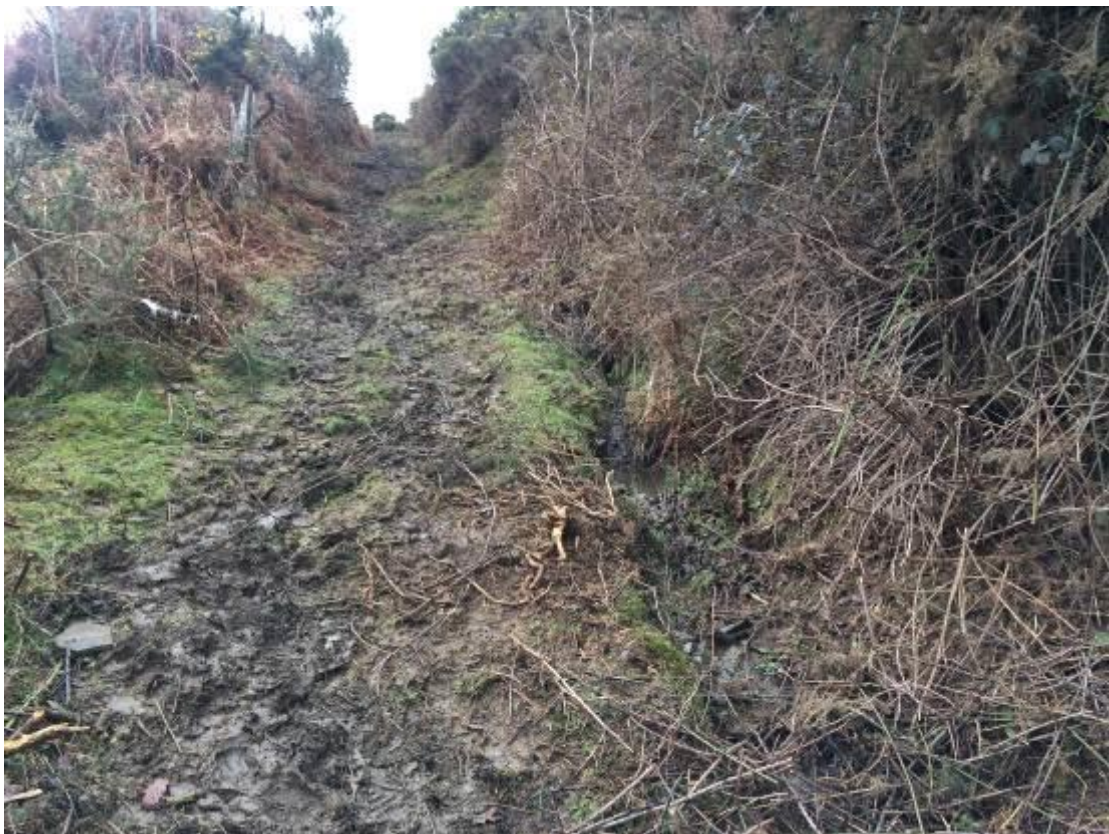
A small issue of ground water was observed emanating at the northern edge of the recently cut access track, flowing over the track and disappearing to ground approximately 50m to the south (Photographs 18, 19 & 20).

**Photograph 18 – Small issue of water alongside access track**

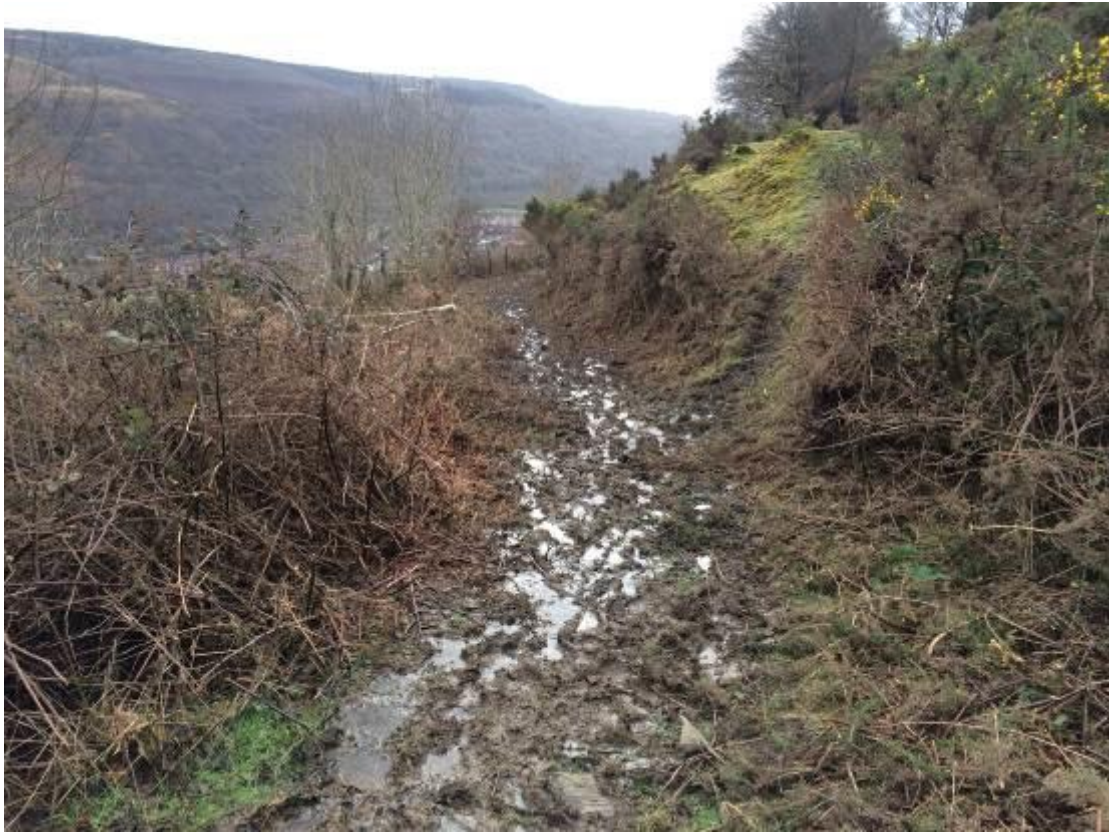
**Photograph 19 – Water flowing along route of access track**

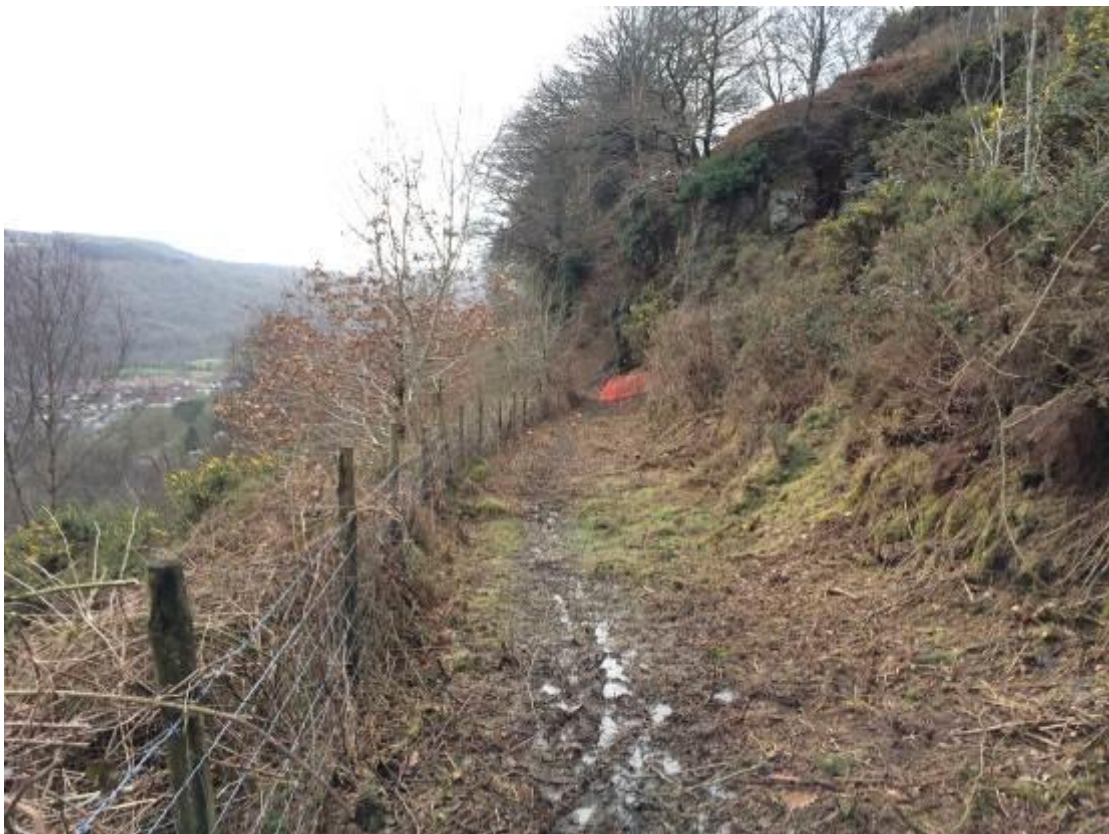
**Photograph 20 – Surface water flows disappearing to ground**

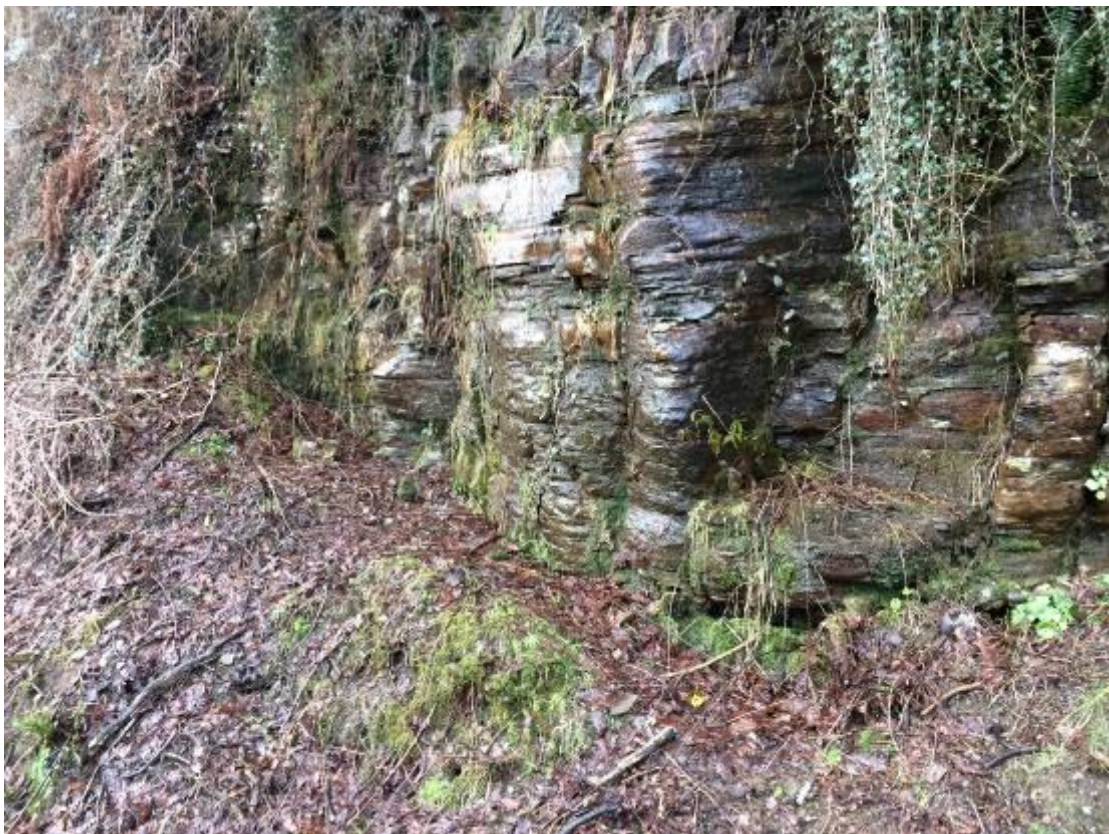
A moderate to strong seepage of groundwater was observed emanating at the mid-point of the cliff face. Flows were disappearing to ground at the base of the cliff, with no ponding present (Photograph 22).

**Photograph 22 – Moderate seepage from cliff face**

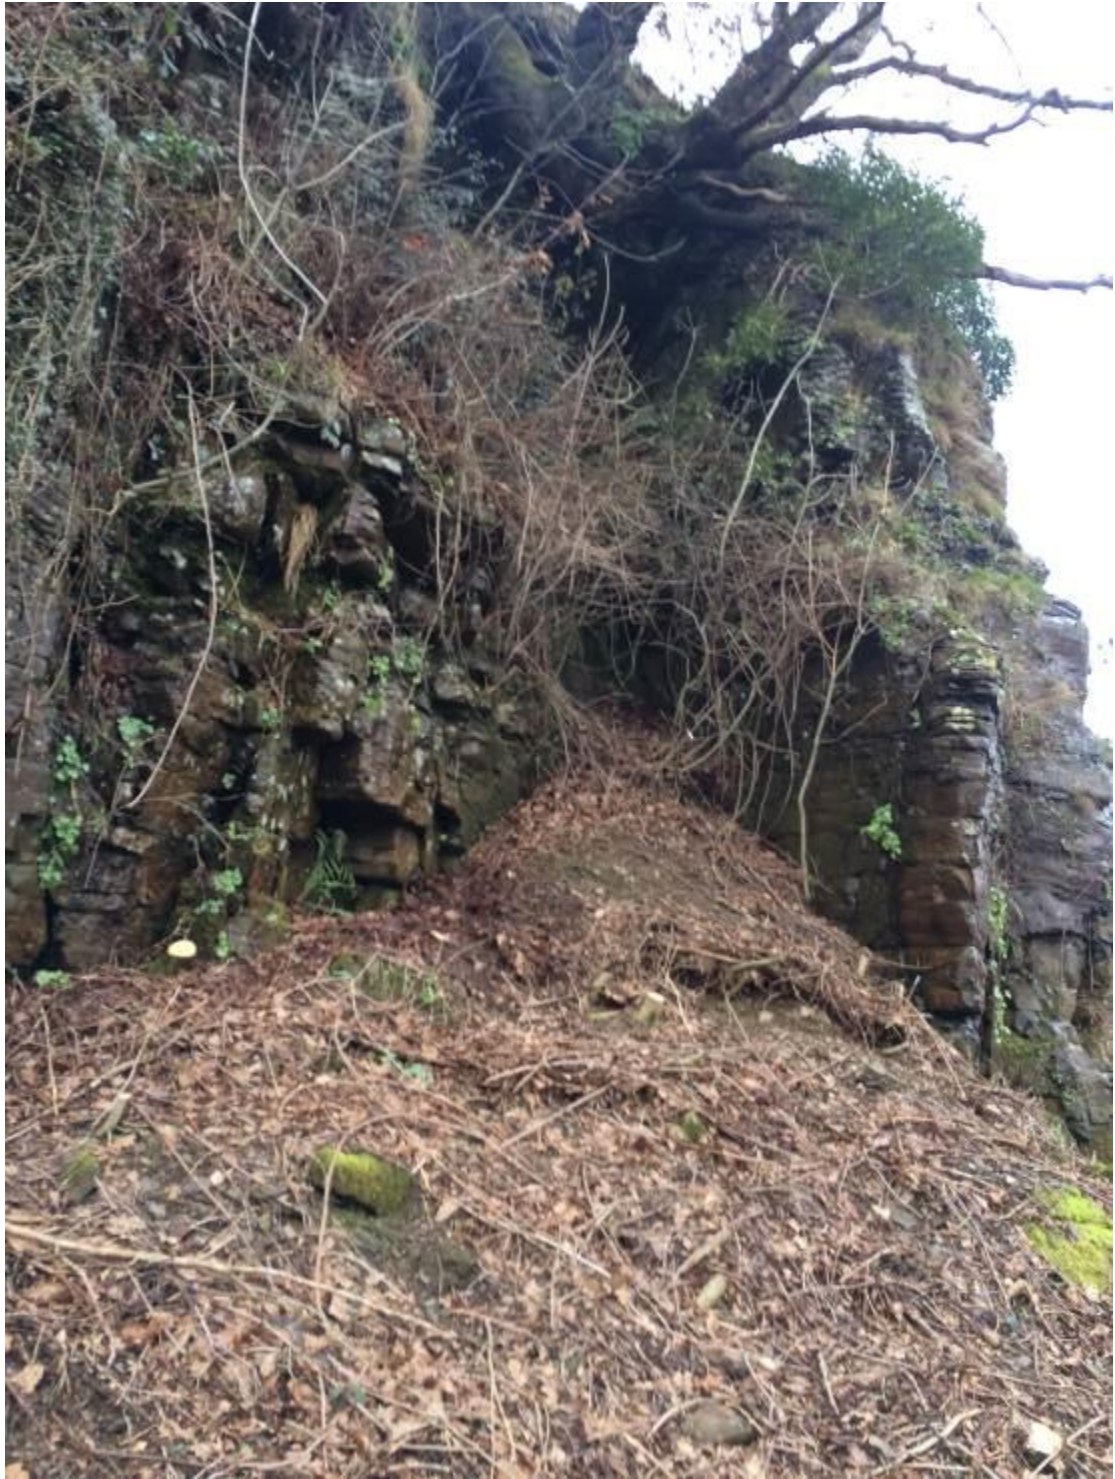
Minor recent slumping of rock debris was observed at the base of the cliff, with the majority of the cliff base being masked by historic scree material (Photograph 23).

**Photograph 23 – Slumping of debris from crest to toe**

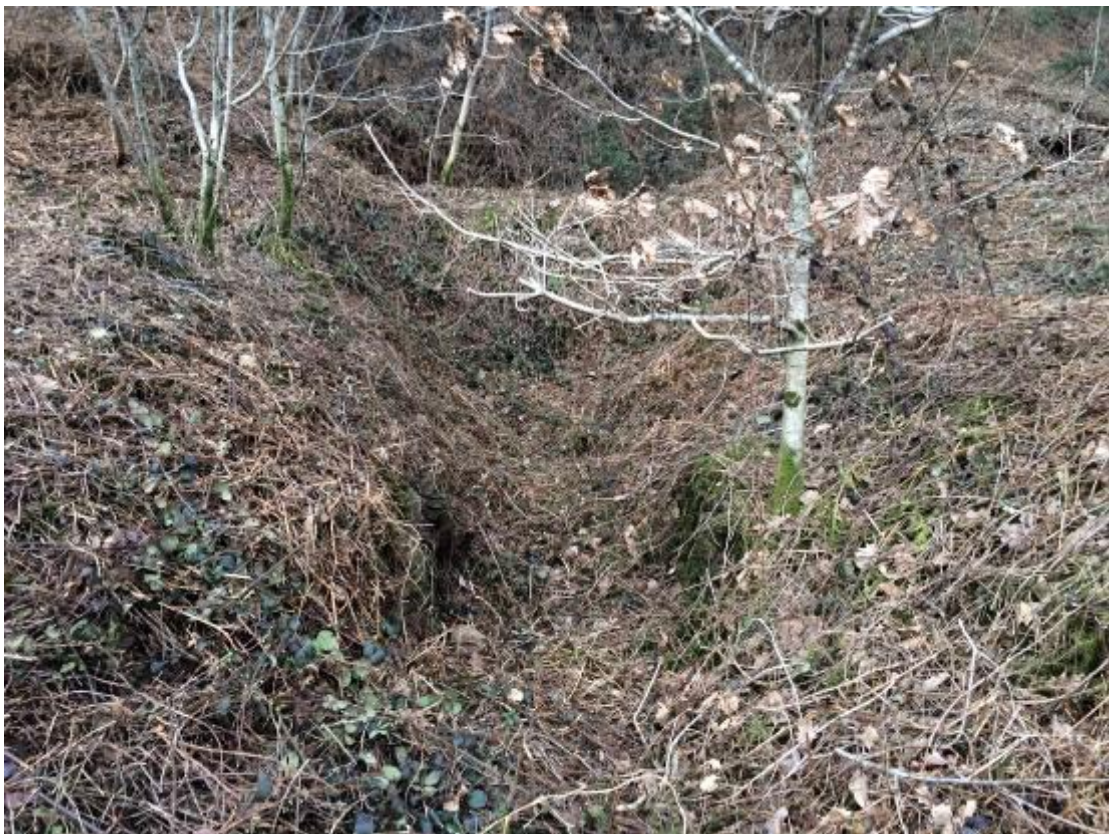
The position of a recorded adit at the base of the cliff was inspected, with the feature evidently having collapsed at some time in the past. There was no water discharging from the adit position (Photograph 27).

**Photograph 27 – Location of adit ref: 276208-040**
