The Coal
Authority

MYNYDD DRUMAU – HYDROGEOLOGICAL CONCEPTUALISATION

**As related to the Skewen mine water
outburst January 2021**

November 2021

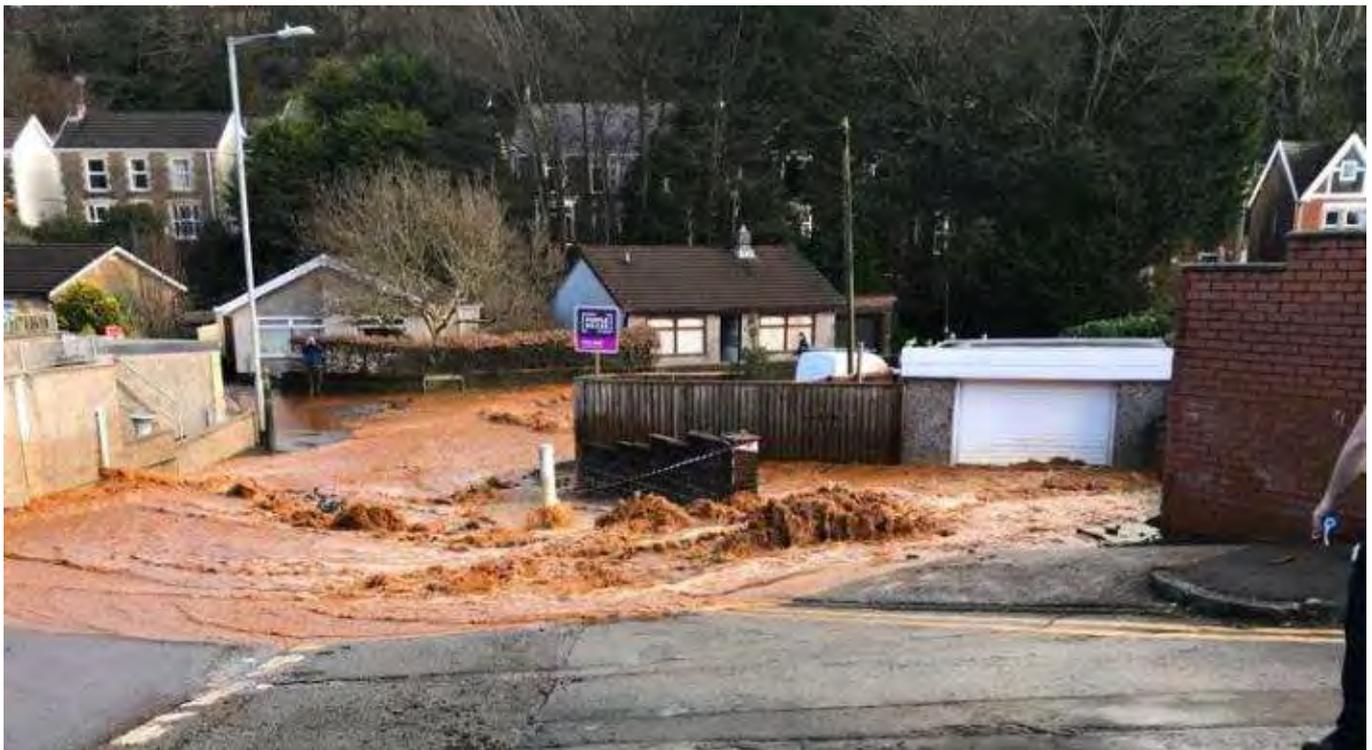
Plate 1: Early stages of the outburst event Goshen Park - 21 January 2021

Media footage shows an outburst of ochreous water (**Plate 1**) close to the junction of Goshen Park and Drummau Road, which flowed from that point south to Dynevor Road (**Plate 2**). The initial outburst flow occurred at a very high rate, with a turbulent upwelling up to 1 metre above ground level observed during the early stages. The water flowing during the first 10 hours of the event was ochreous (orange and opaque). The flow rate of water discharging reduced with time and water clarity improved, becoming clear at some point overnight (21-22 January 2021).

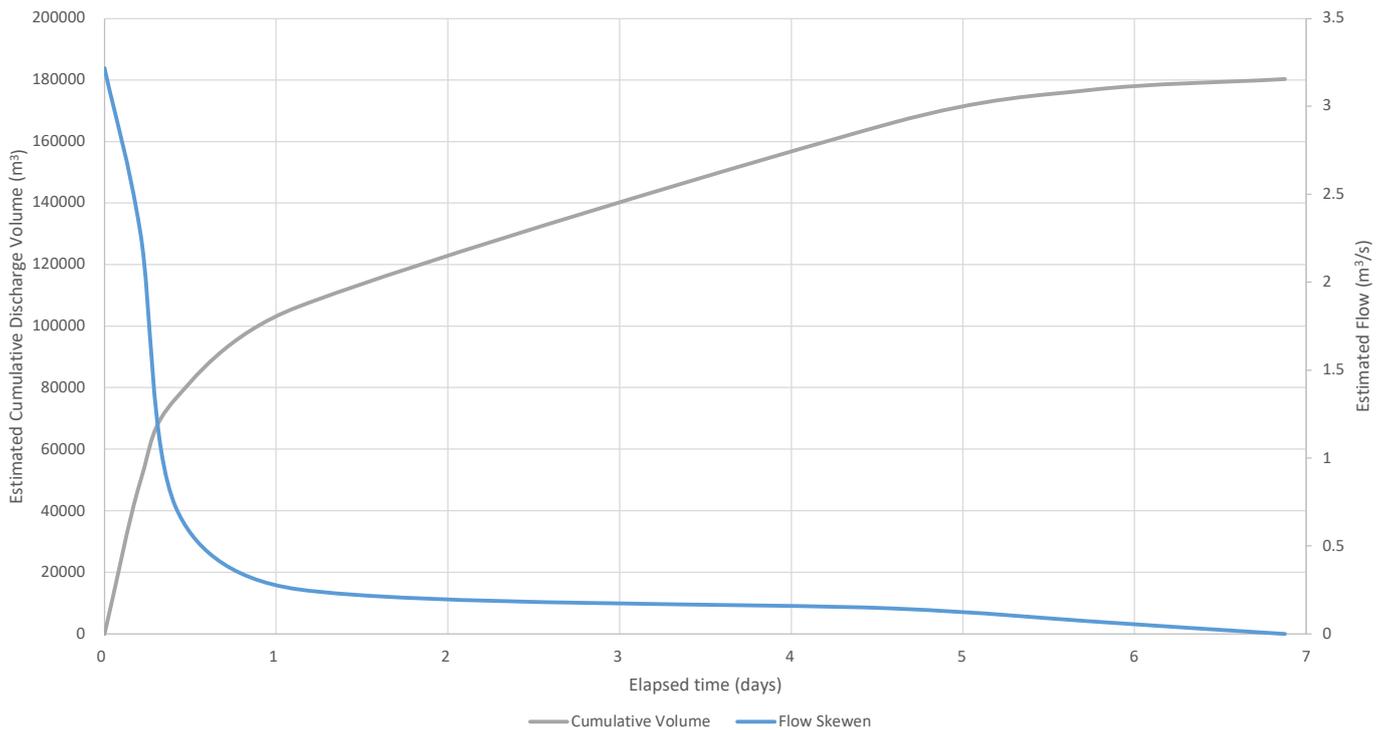
Figure 2: Skewen outburst estimated flows and volumes

flow curve for the first 7 days of the discharge from Goshen Park. This flow estimation together with derived discharged volumes are presented in **Figure 2**.

These estimations show that it is likely that 100,000 to 200,000 m³ of water was released during the initial phases of the outburst **Table 2**.

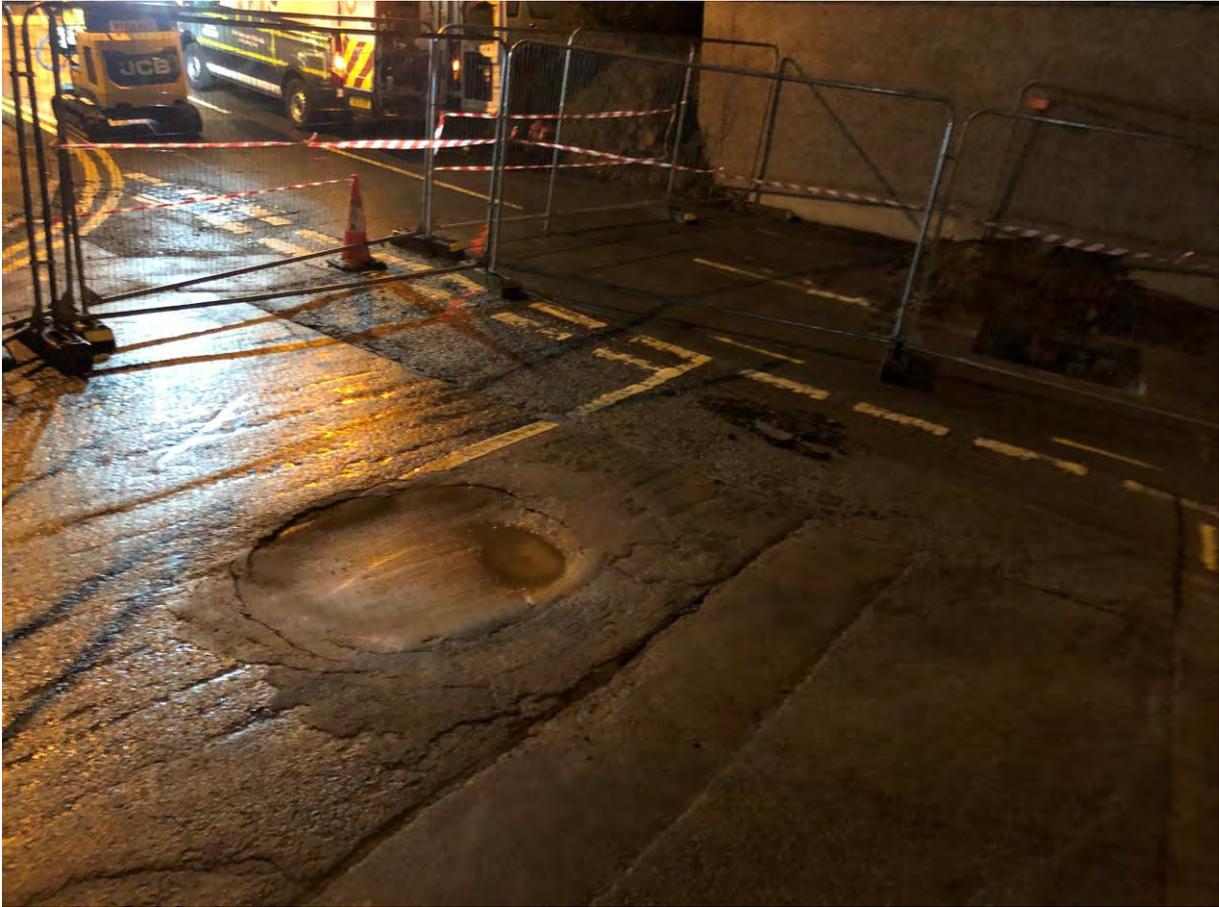
Plate 1: Feature 1 after the outburst (2021-01-22 00:51 AM) (Coal Authority)

- **Feature 1** – shallow circular depression in tarmac at road junction (**Plate 3**). Surface tarmac collapsed in days following the outburst revealing a 1-1.5 m deep void. Drilling of this feature to beyond the level of the Skewen Level/Drummau Road Drift identified fill like material to the elevation of the level.
- **Feature 2** – outburst location (**Plate 4**), irregular almost vertical pathway 1 to 2 m wide exhibiting no definitive signs of being “engineered” or supported. The features form has been delineated and found to be approximately 17 m in depth. The output of a downhole Sonar survey is presented in **Figure 5** to aid visualisation.

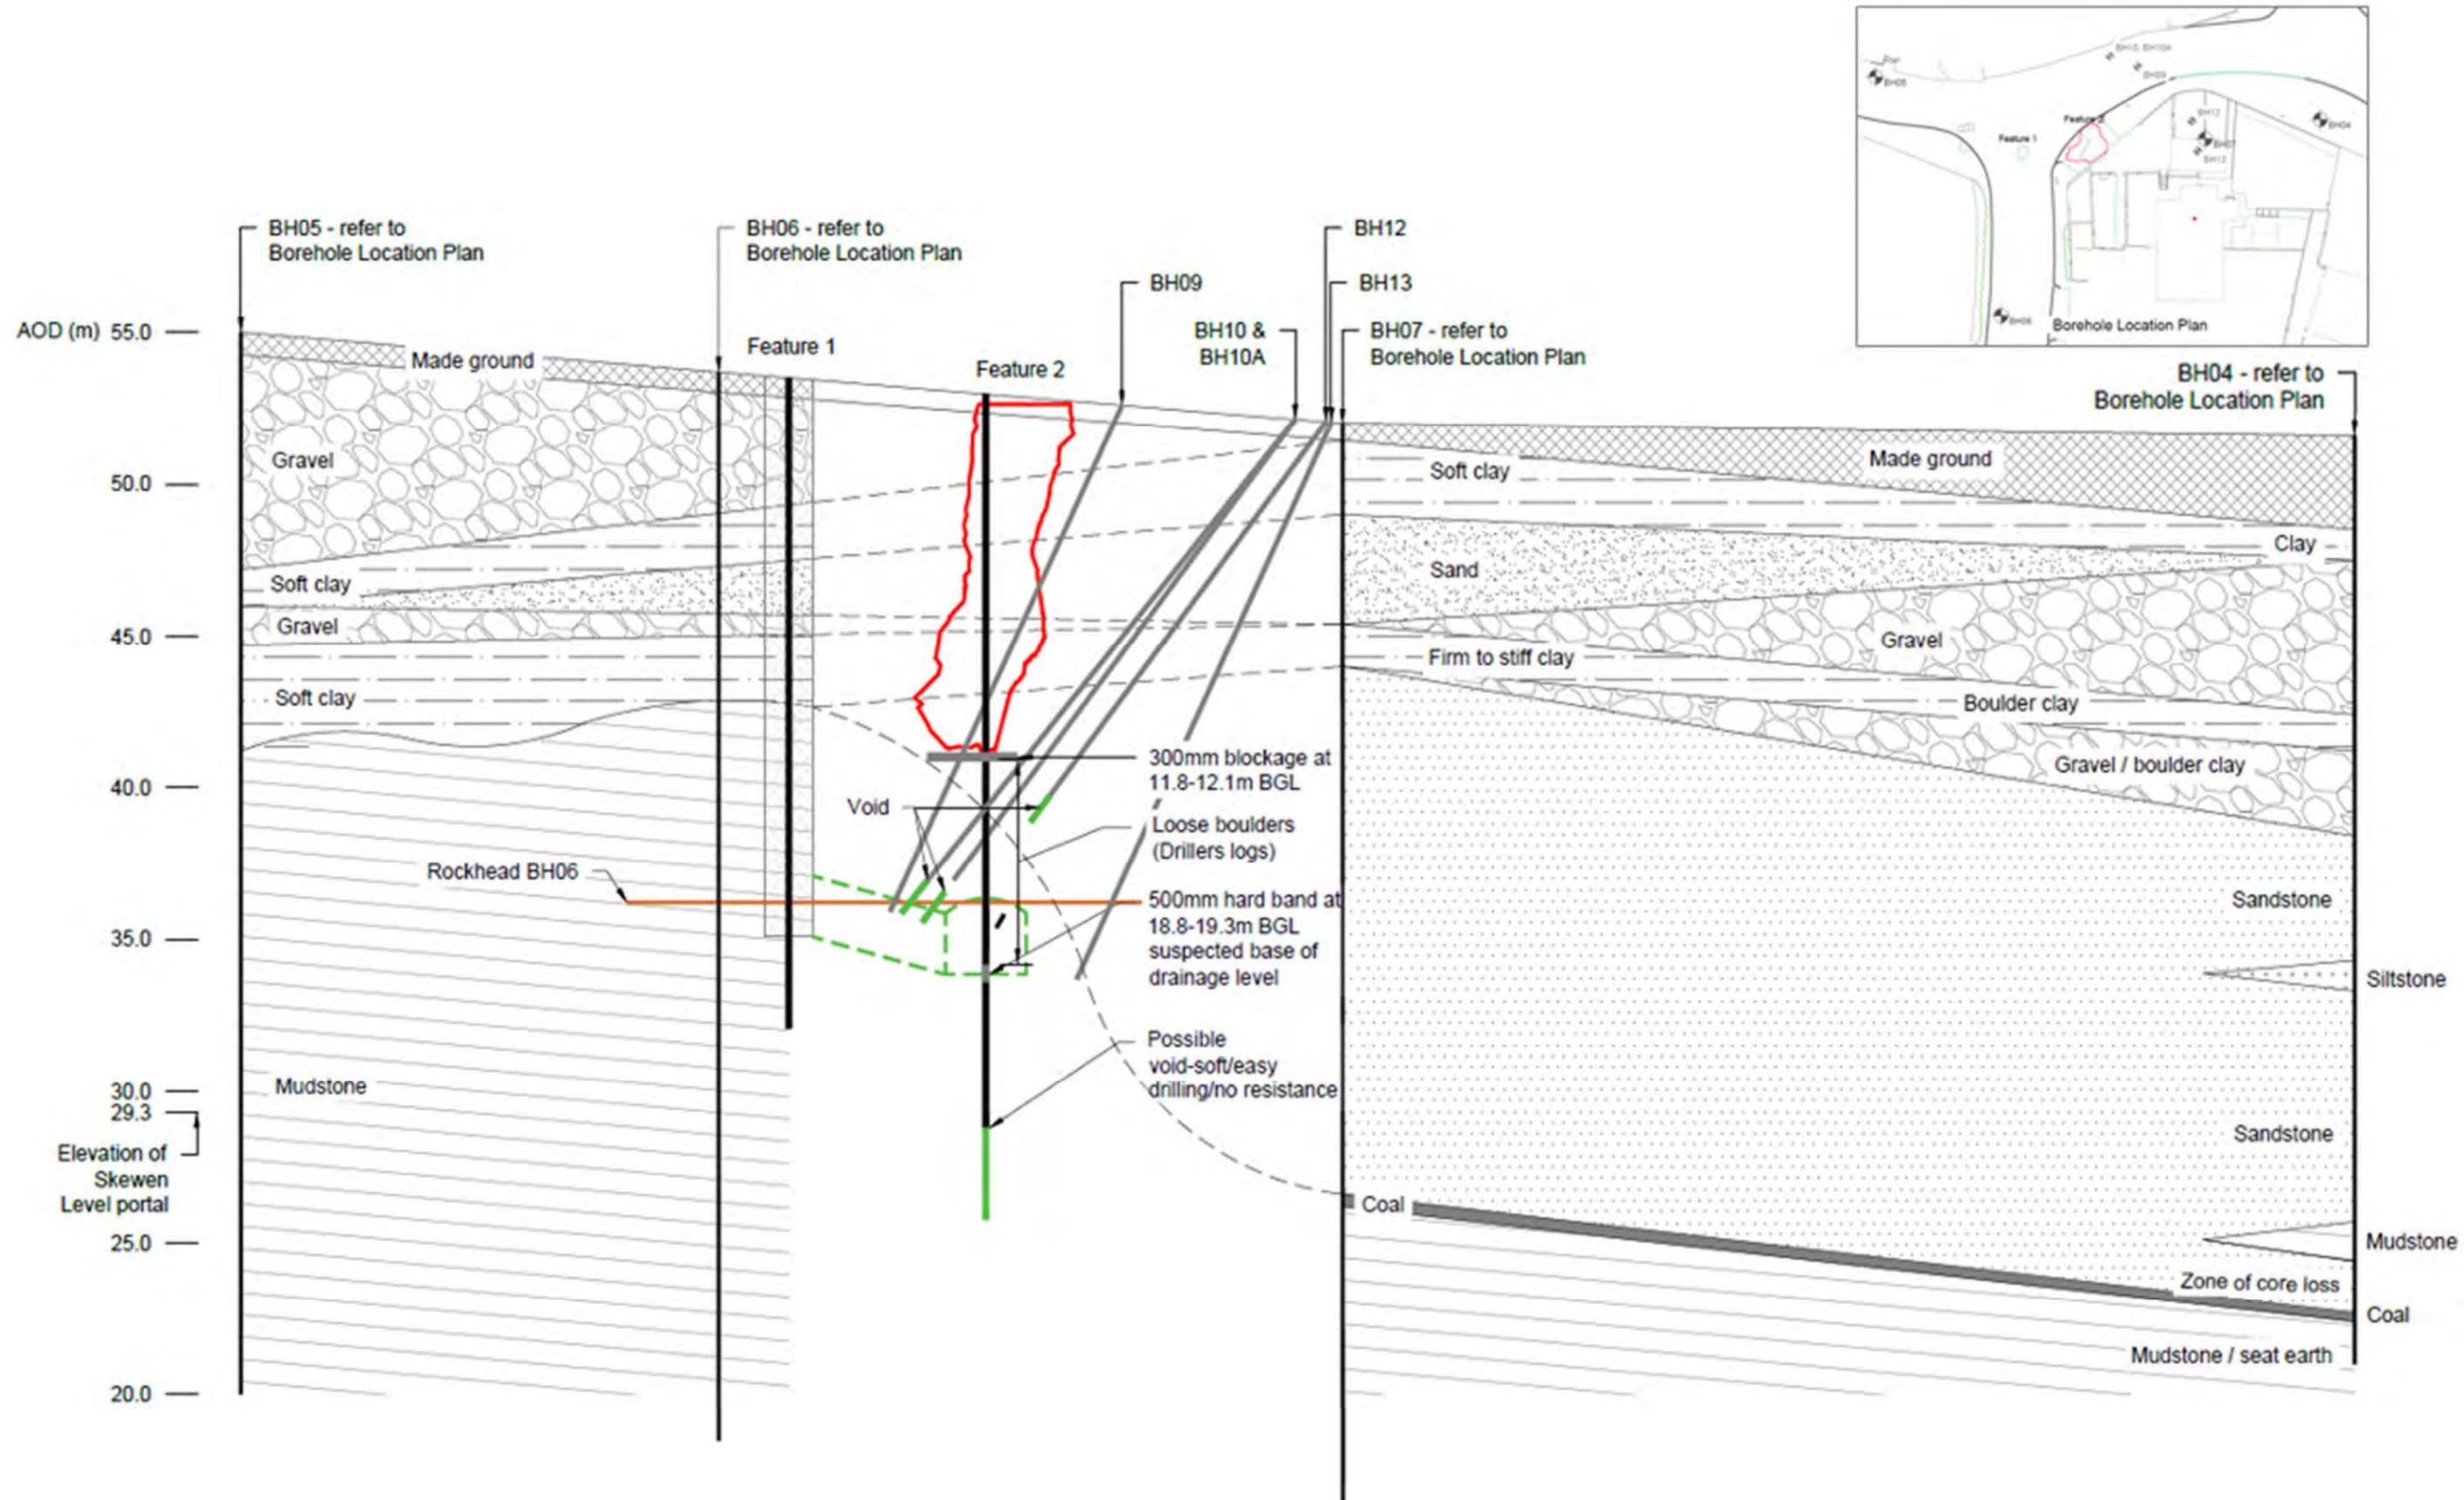
Figure 4: Conceptual Ground Model Following Phase 3 Ground Investigation

Subsequent to the incident the Coal Authority have undertaken extensive ground investigation works to assess the area. Detail of the observed ground condition around the outburst location is included in **Figure 4**. The intrusive investigations showed the following in the area close to the outburst location:

- Variable thickness of unconsolidated material generally to approximately 10 mBGL comprising made ground, clays (including boulder clay), sands and gravels;
- Rock-head interpreted as lying between 7 and 14 mBGL;
- Solid geology comprised mudstone and sandstones;
- Disparity between solid geology encountered to the east and the west of feature 2 possibly indicating fault displacement in the area; and
- Void assumed to be mining related and likely the Skewen Level/Drummau Road Drift or offshoots identified in inclined drilling and vertical drilling directly in the base of Feature 2 at approximately 20 mBGL.

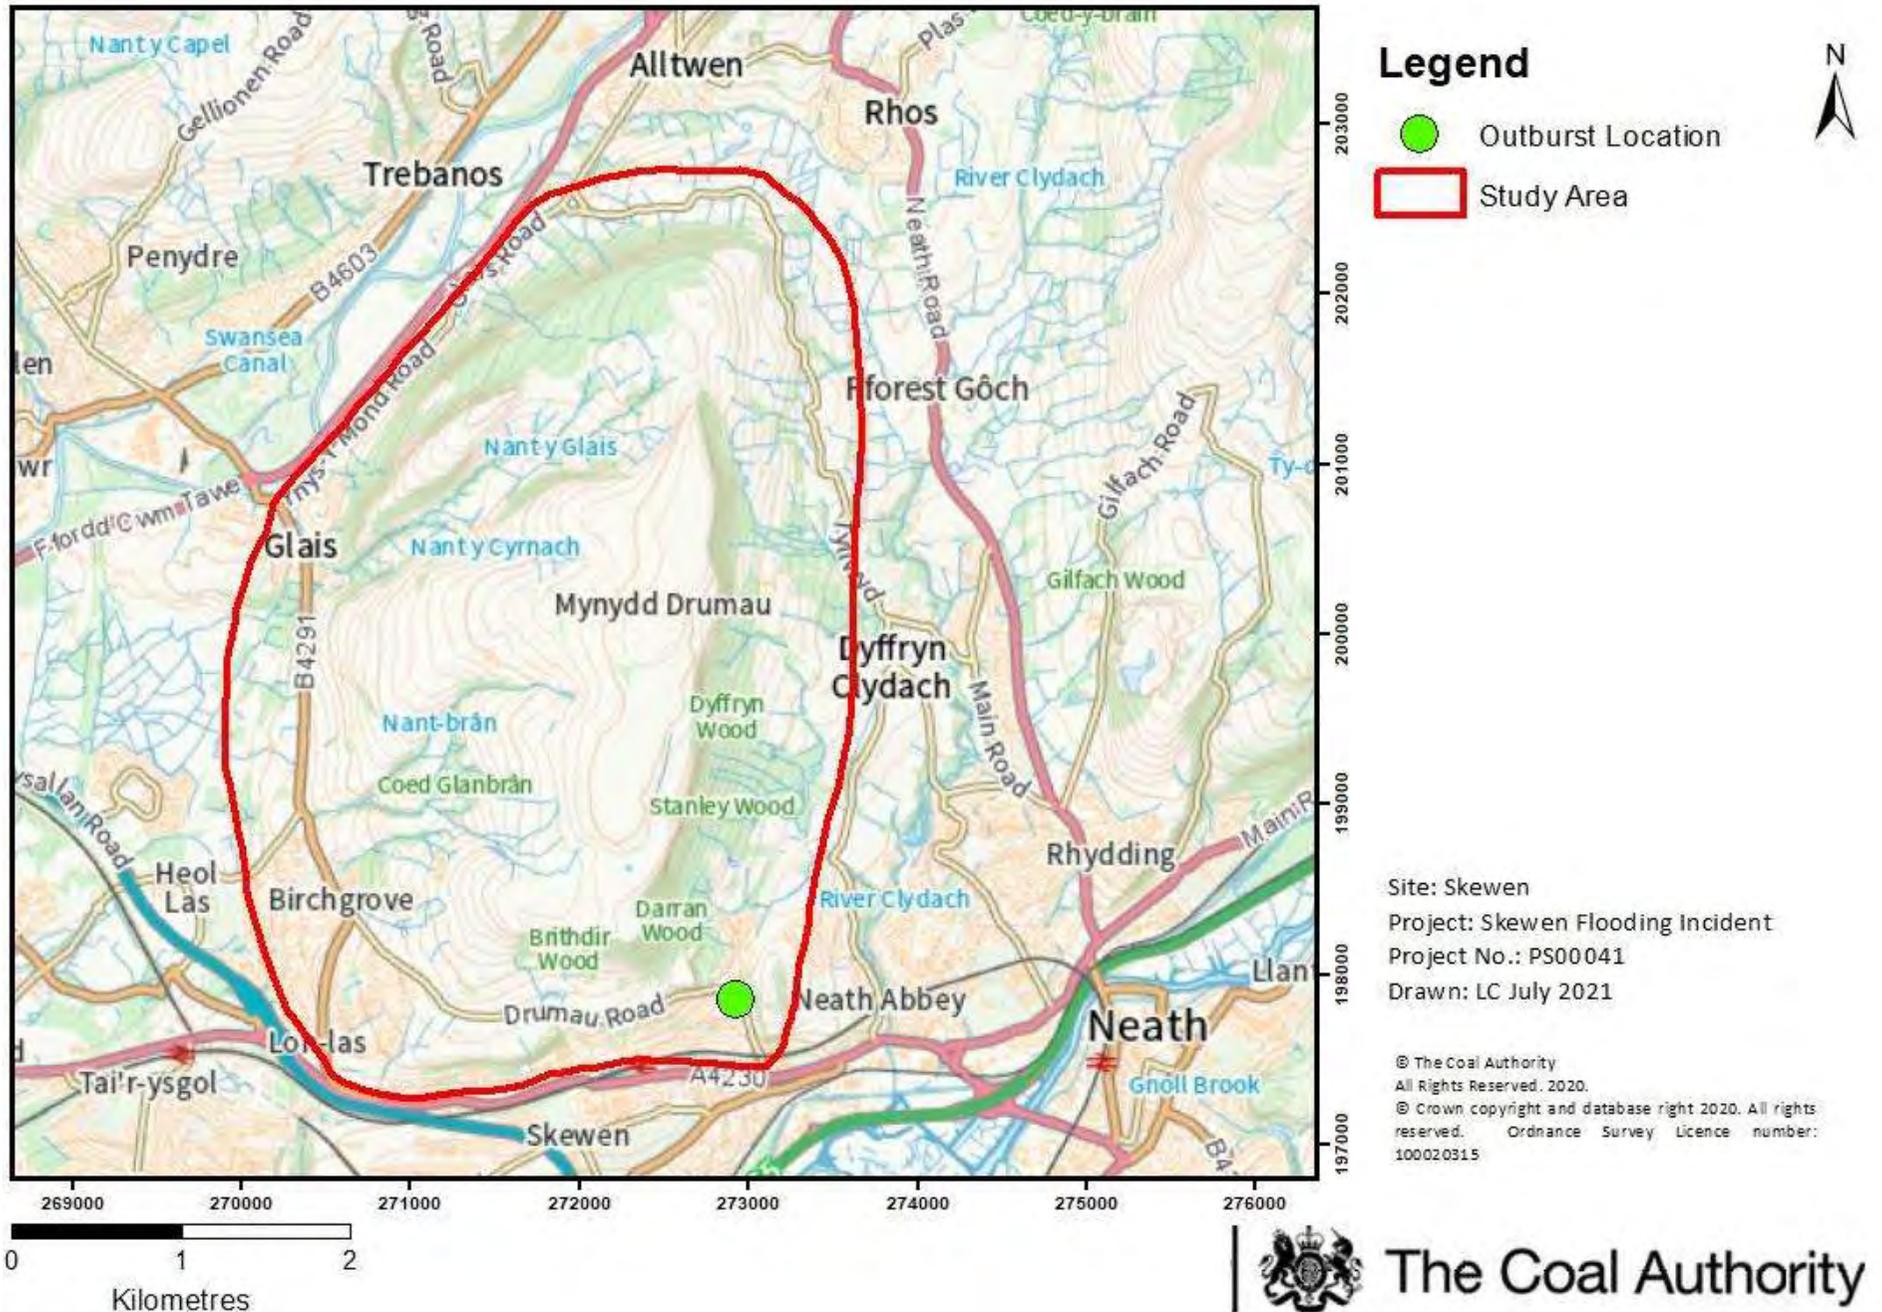
Figure 6: Map of Mynydd Drumau catchment/study area

Following the outburst event an initial review of the local area both using desk based information sources and on the ground observation allowed the Coal Authority to define a specific study area to be further investigated. This area is loosely delineated by:

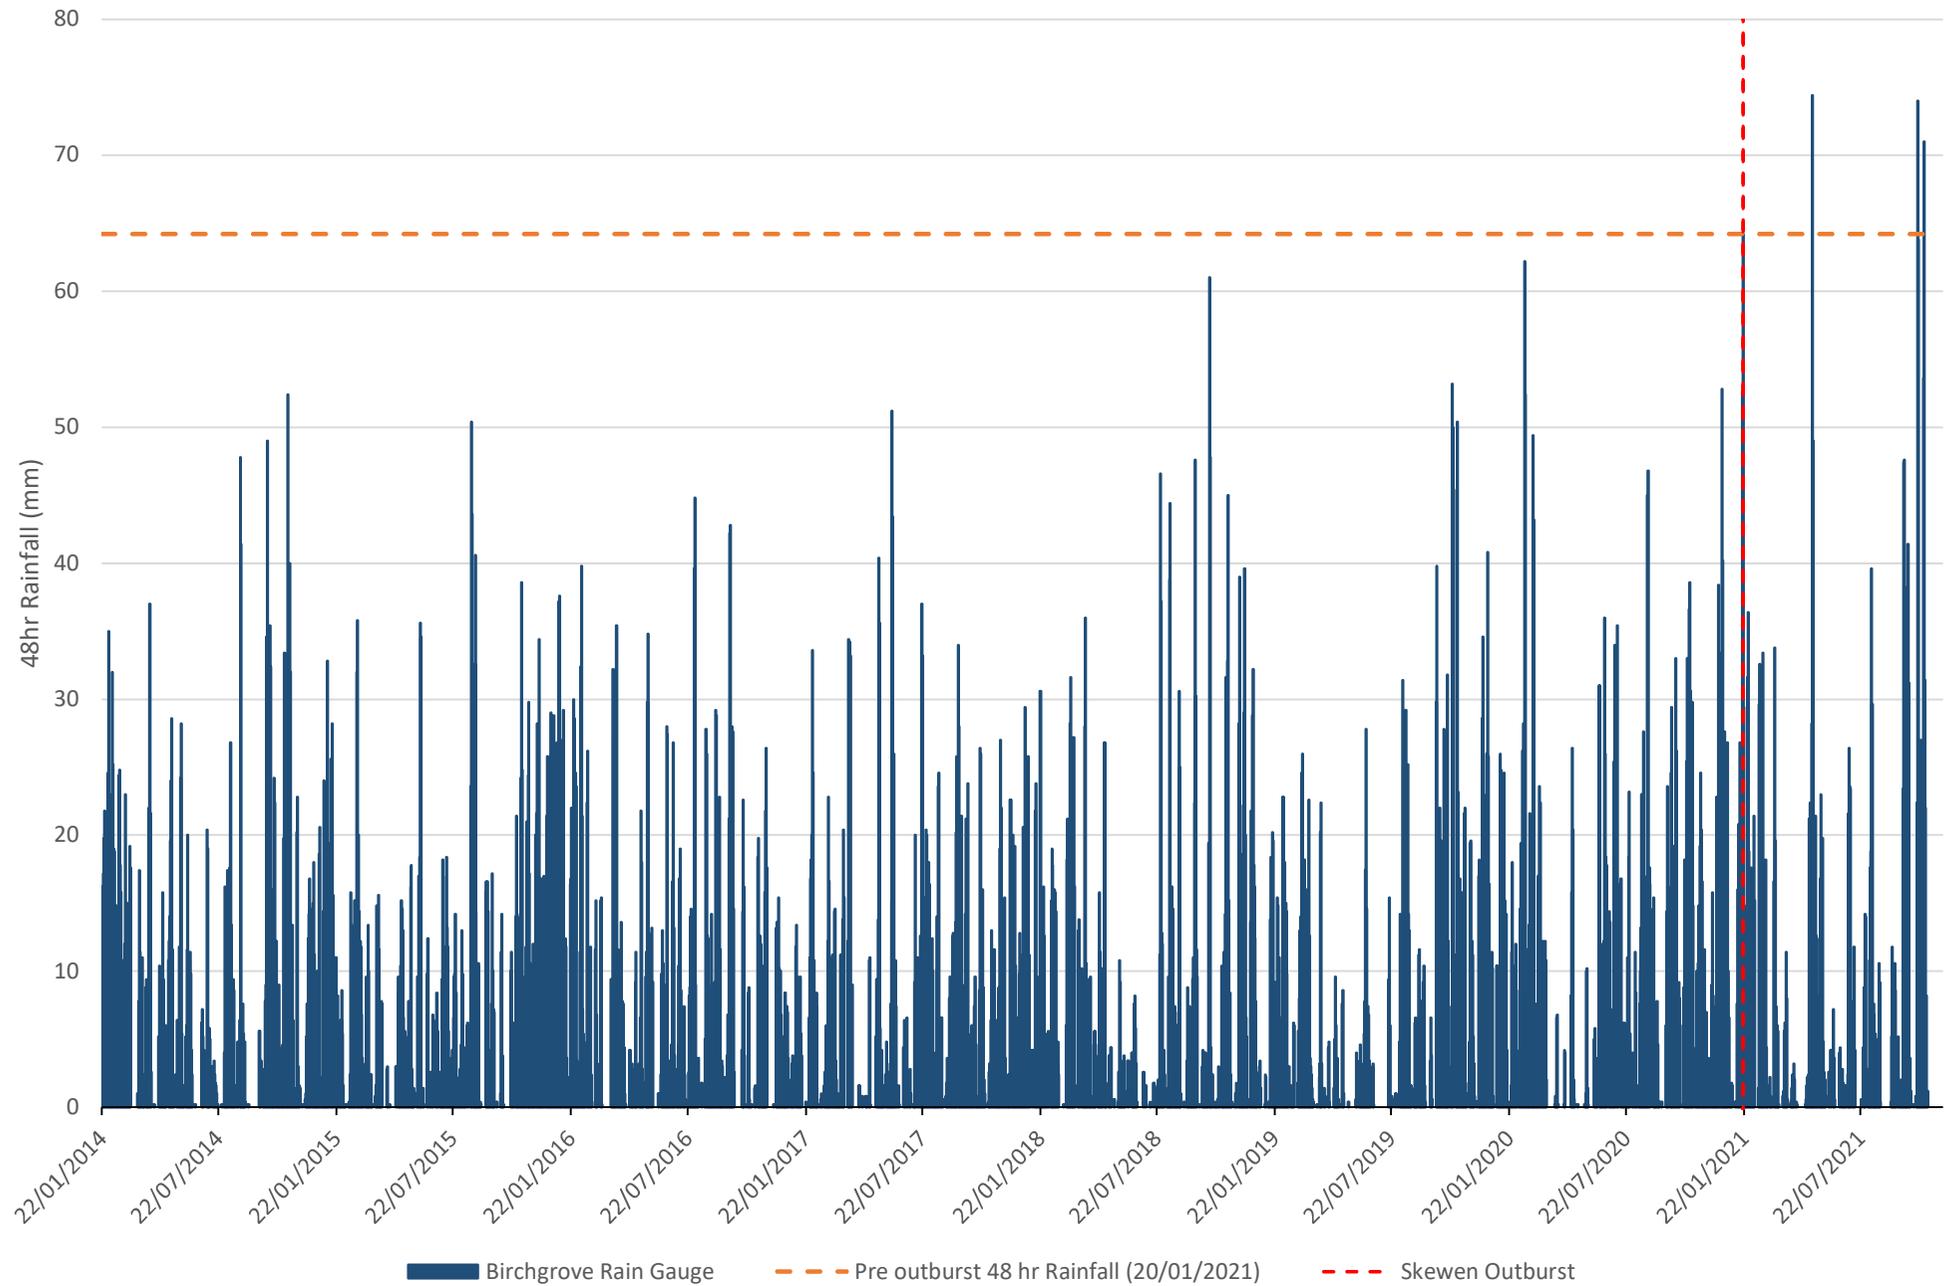
Figure 7: Two day rainfall for Skewen area (Birchgrove Main) 2014 - 2021

The rainfall data record spanning the outburst event has been reviewed by the Coal Authority. The high frequency data has been used to calculate the 48 hour rainfall totals to identify periods of sustained high intensity rainfall. This data is presented in **Figure 7** and **Figure 8**. This analysis shows that in the two day period preceding the outburst event (Storm Christoph) a two day rainfall total of 64.2 mm was reported. This is the highest two day rainfall total recorded at the Birchgrove rain gauge to this point in the seven year dataset. It is noted that the average January monthly total rainfall recorded at this station is 151.86 mm and the January average 48 hour rainfall total is 9.9 mm.

Based on interpretation of the above, it is concluded that whilst the rainfall input to the system, attributable to the higher than usual rainfall during Storm Christoph, this input from this event alone was not sufficient to generate the flow rates or total discharge volumes experienced.

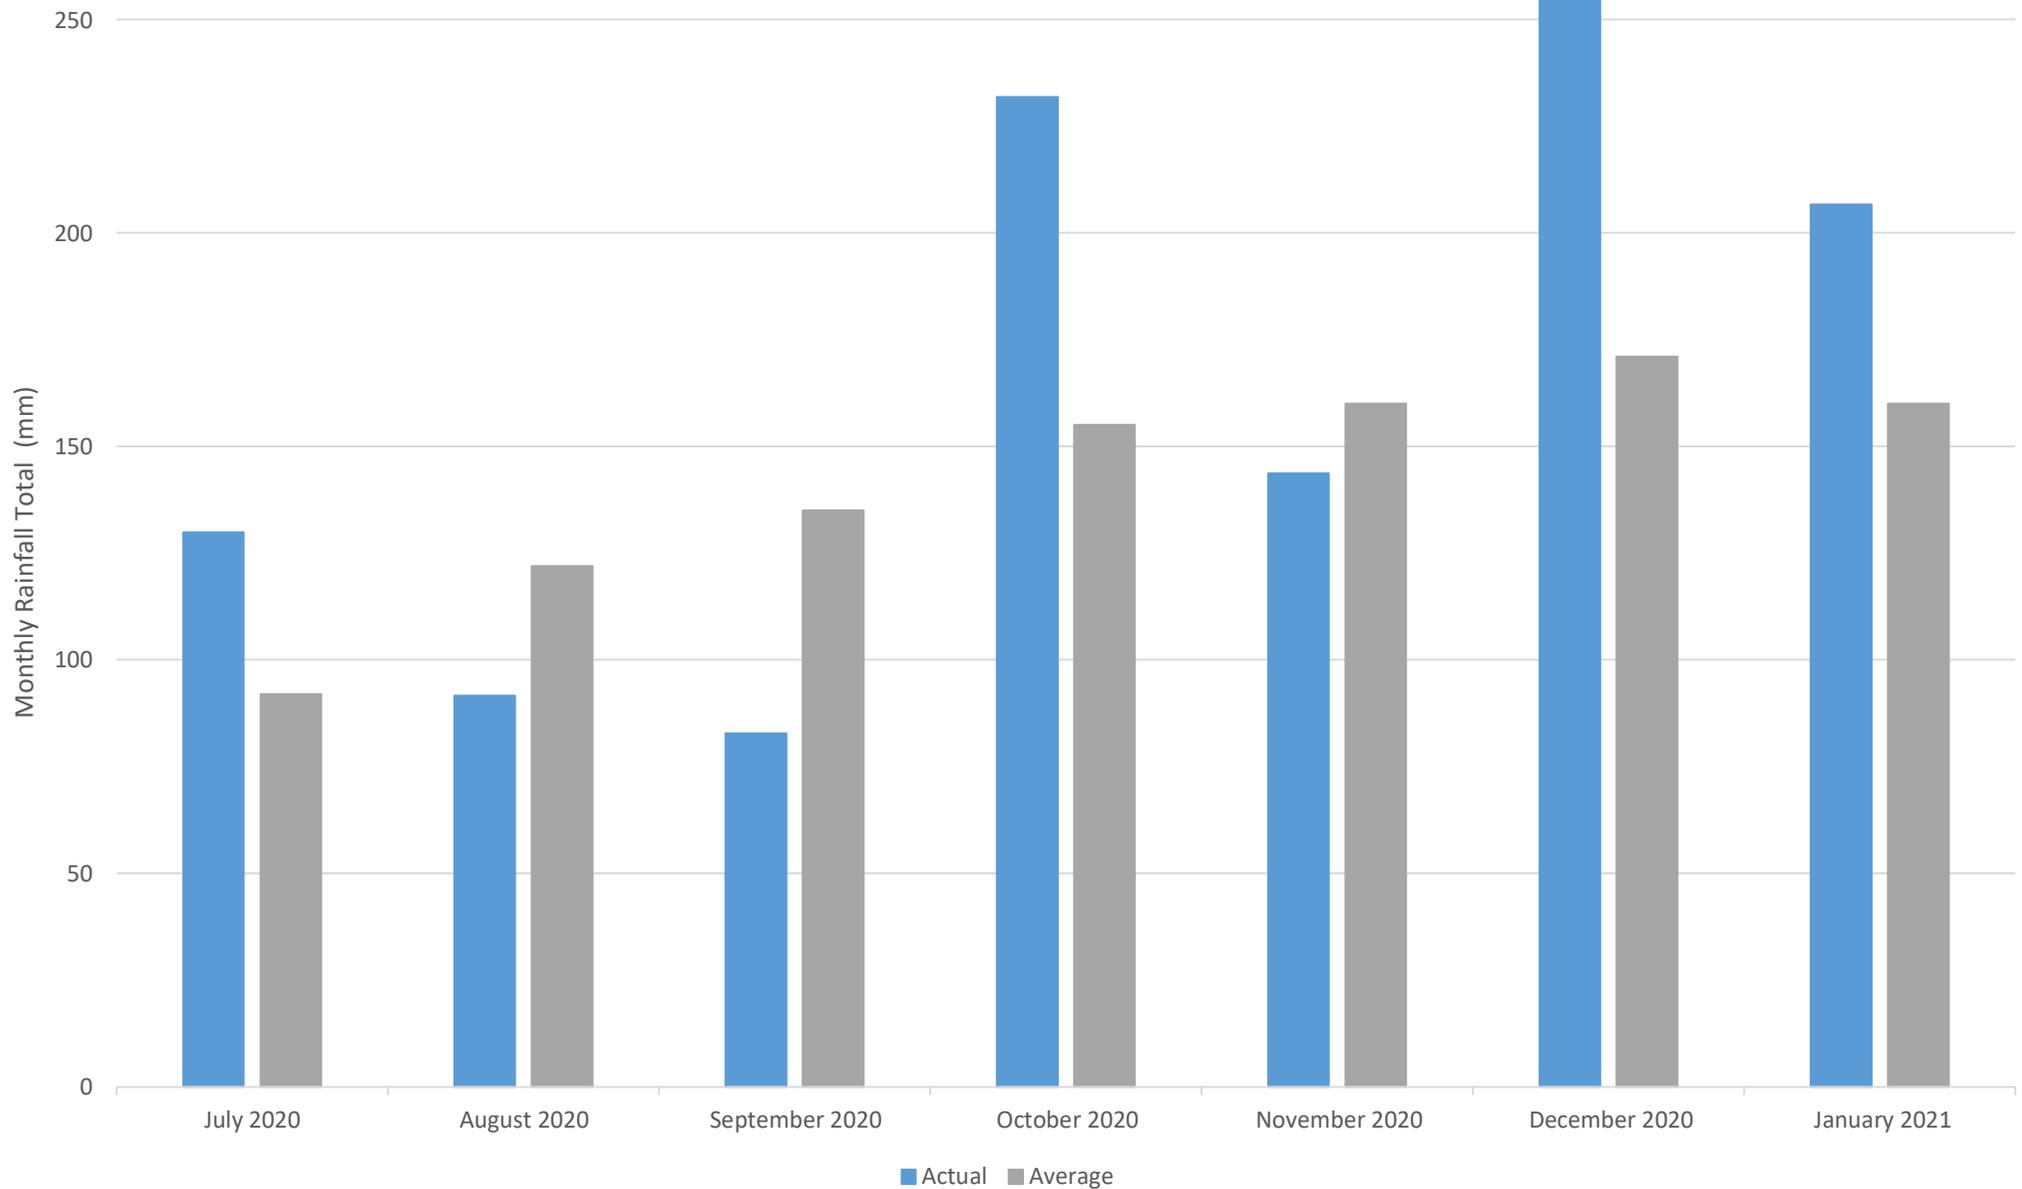
Figure 9: Actual month total versus long term average rainfall (Birchgrove Main)

Natural Resources Wales (NRW) provided a comparison of total monthly rainfall with the long term average for each month. This has been reproduced as **Figure 9** for January 2021 and the six months prior, with the data presented in **Table 8**. The data shows that this full period was wetter than average despite a fairly dry late summer in 2020. The four month period preceding the outburst event experienced rainfall 30% higher than average conditions.

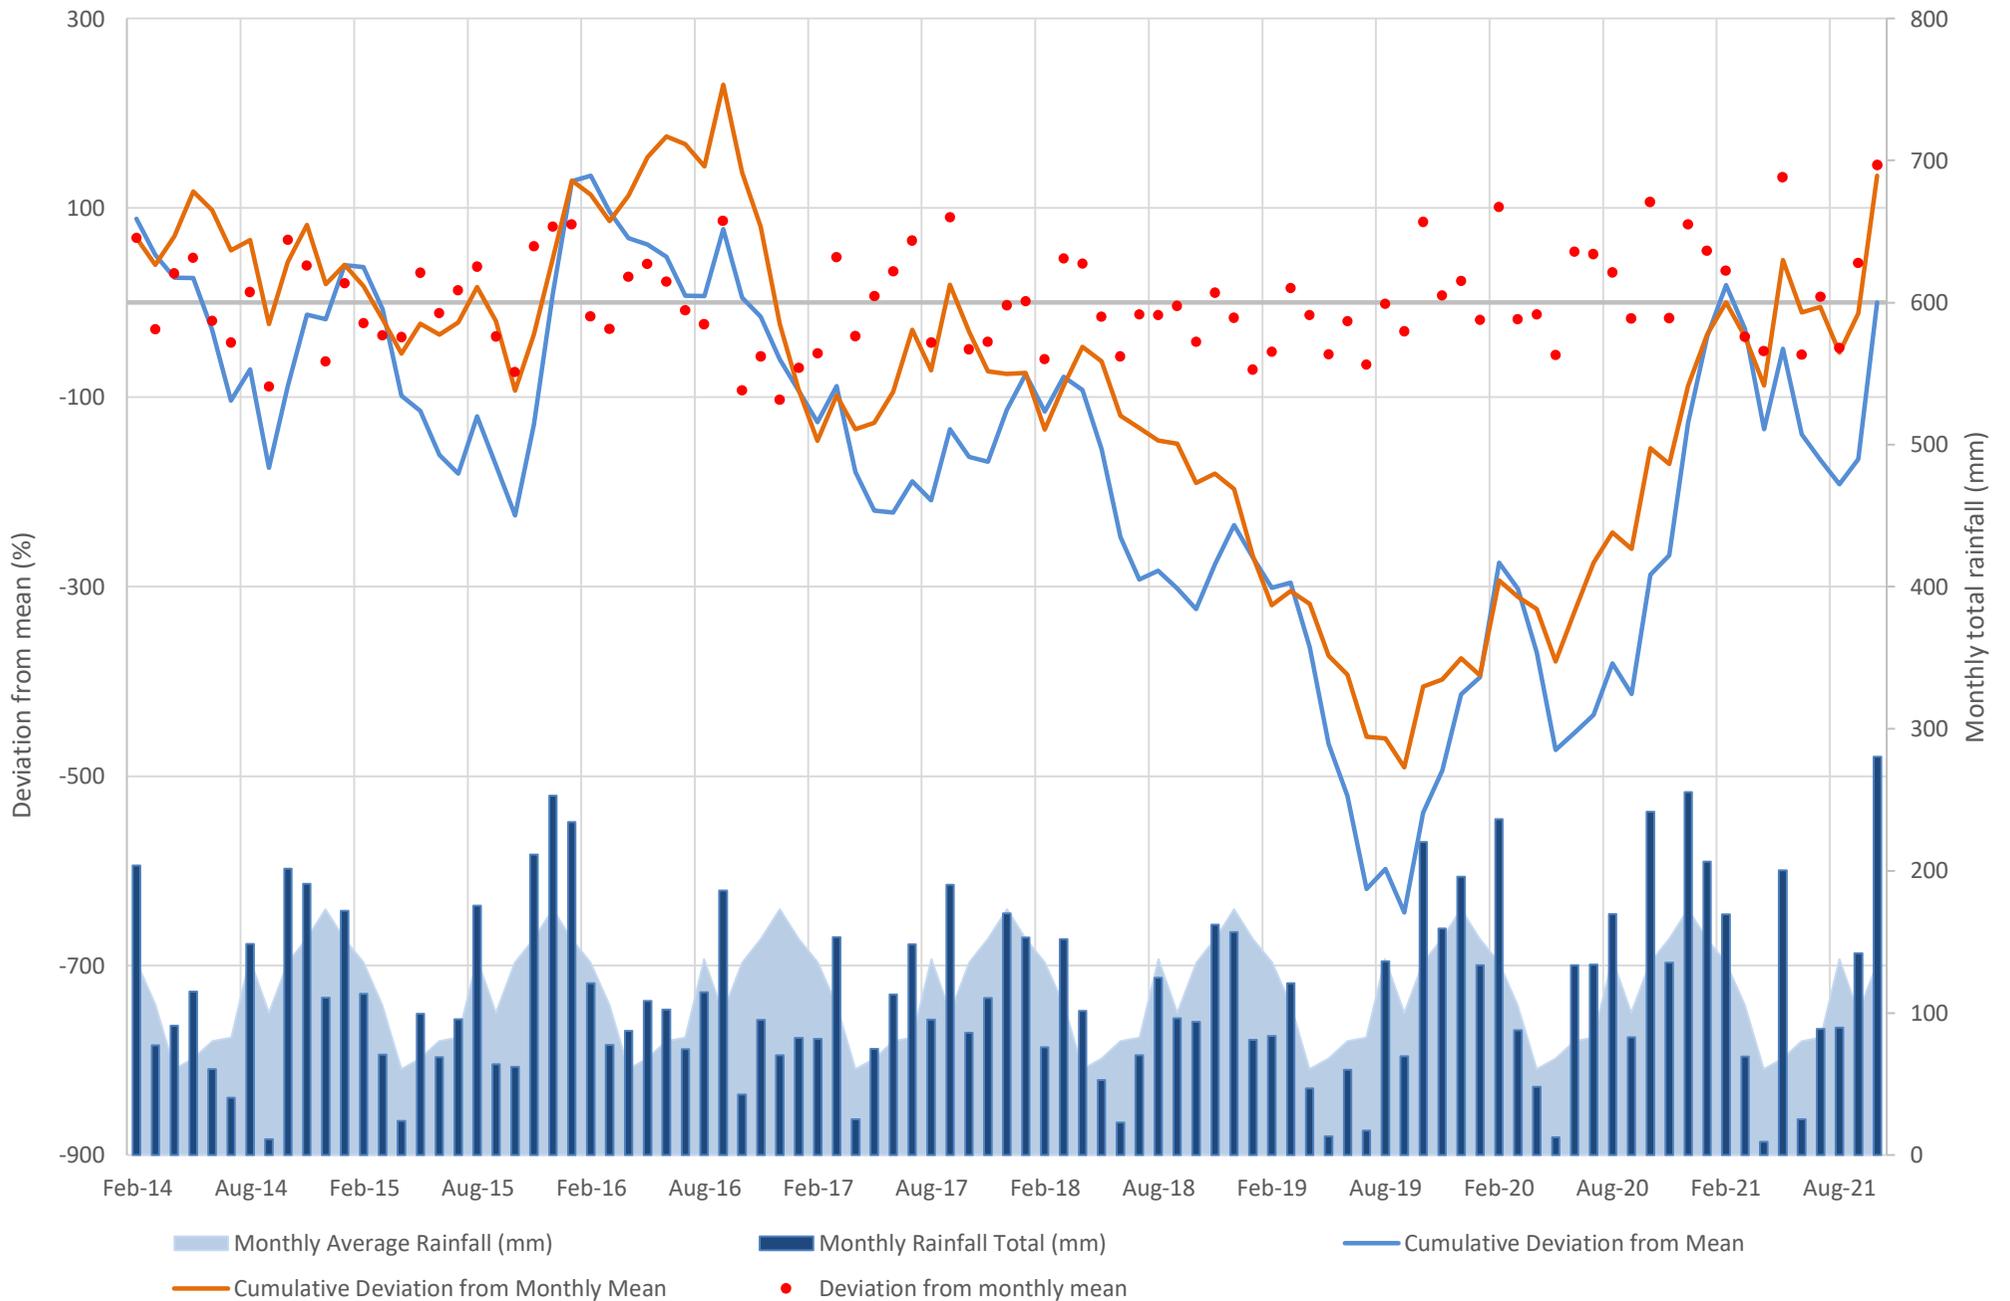
Figure 10: Monthly rainfall total and cumulative deviation from mean (Birchgrove Main)

Given the delayed response of underground waters to rainfall inputs, isolated instances and even months of higher rainfall are less significant than sustained periods of higher than average rainfall. Therefore cumulative deviation from mean analysis of the seven year rainfall data set has been undertaken (**Figure 10**). This analysis shows that from January 2014 to October 2015 the general trend was one of dryer than average conditions. This was then followed by a period of wetter than average conditions from October 2015 to September 2016. In the three years from September 2016 to September 2019 the general trend was one of dryer than average conditions (decreasing gradient). From September 2019 the cumulative deviation from mean rainfall has reduced as shown by the rising gradient indicating ongoing wetter than average conditions to present.

Note: the nature of the analysis is such that the cumulative deviation from the mean trends to zero. The gradient of the line is the indicator of whether a period is wetter or dryer than average.

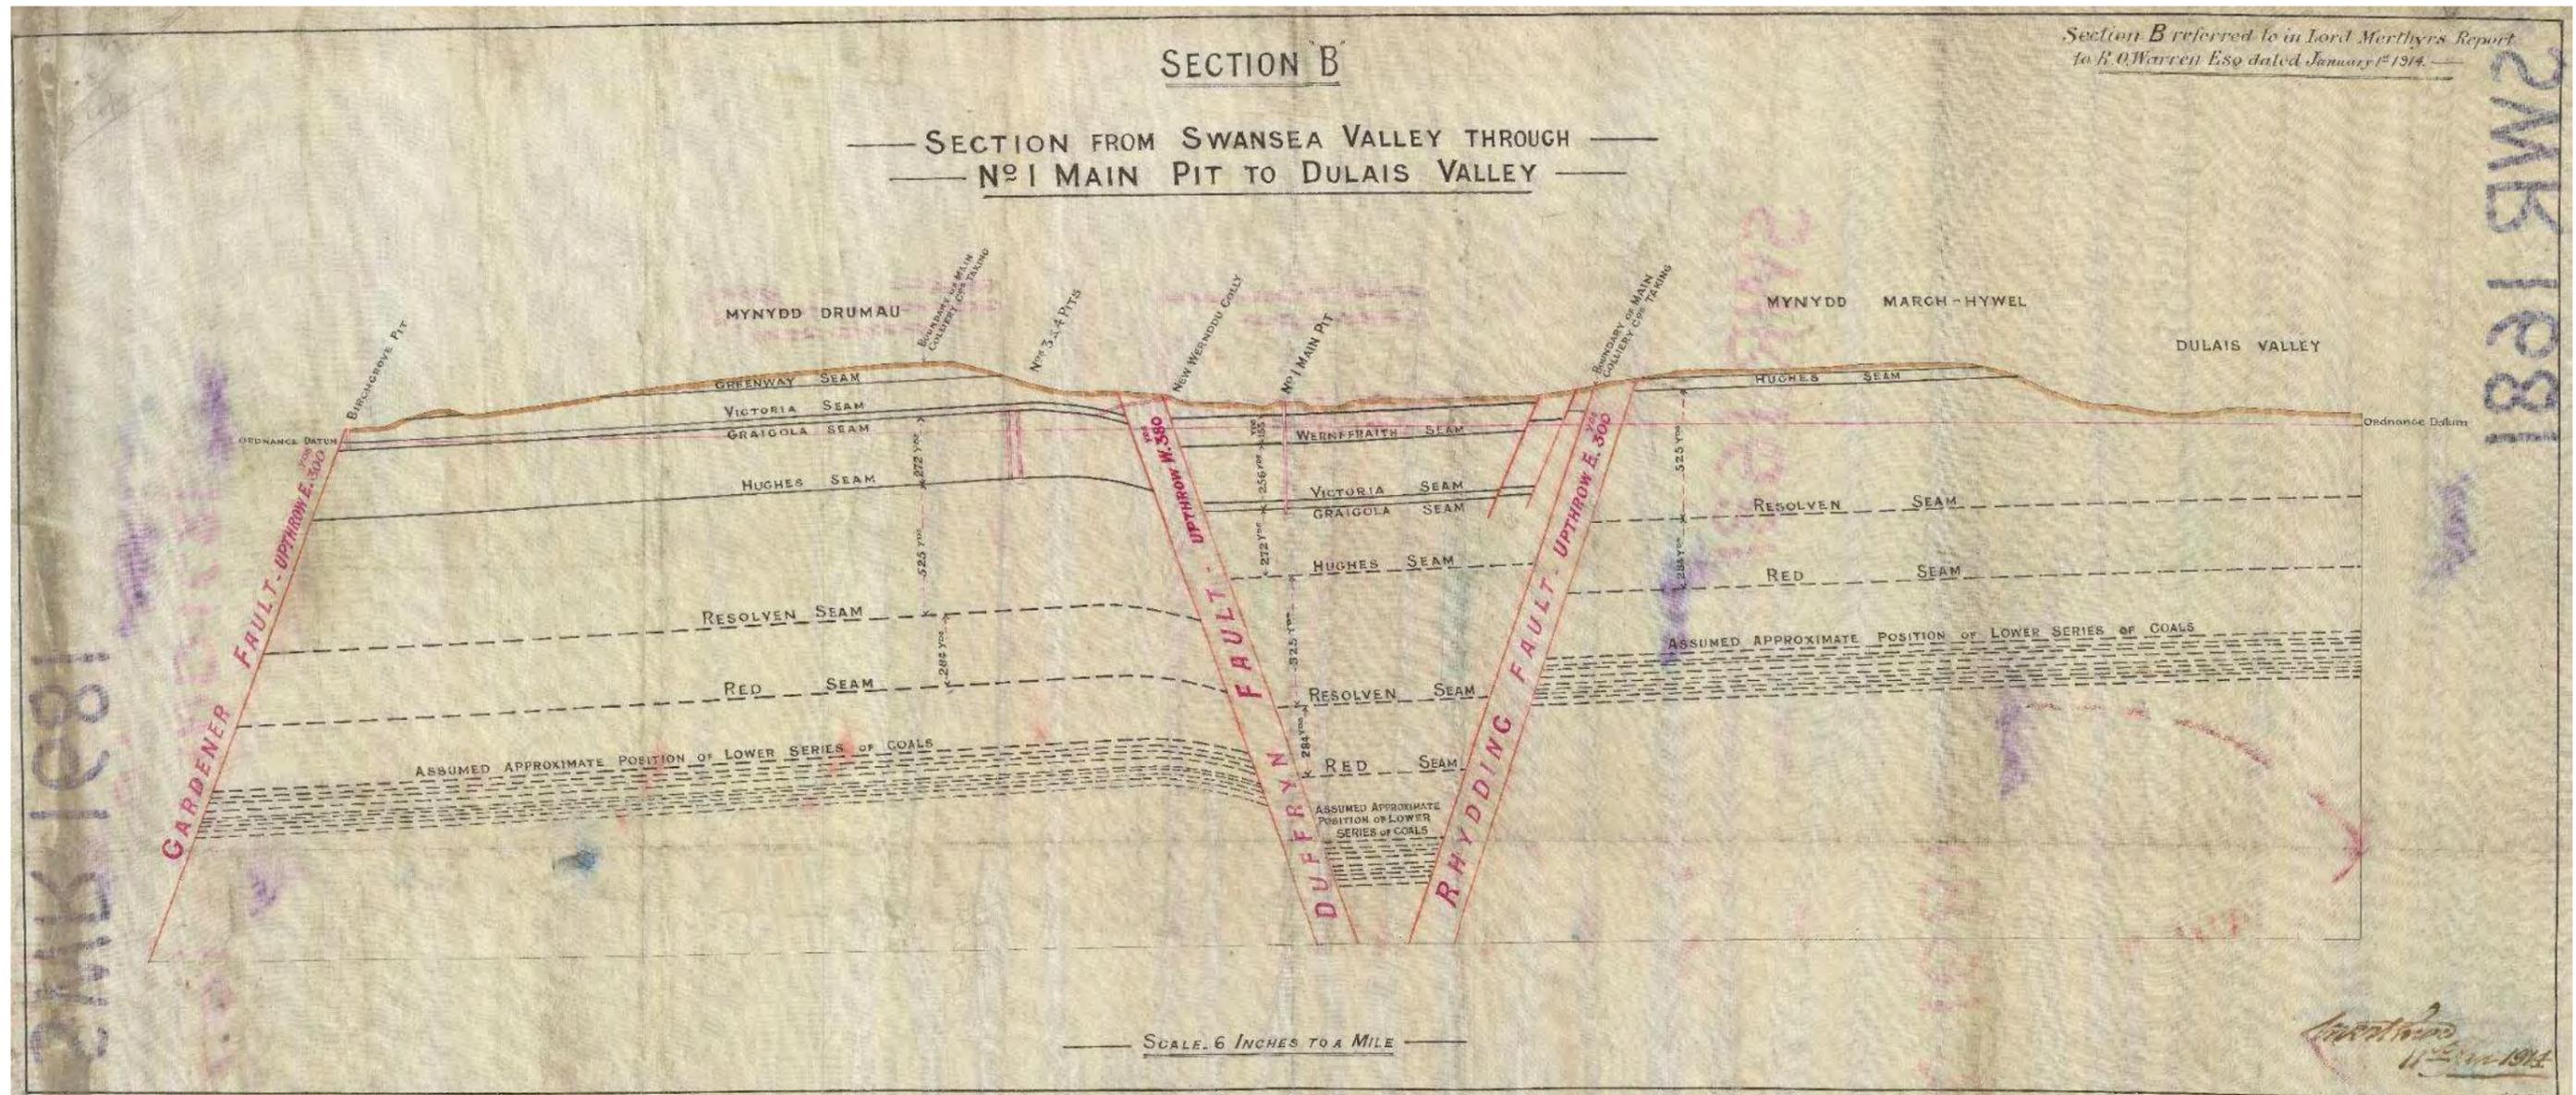
Figure 13: Section from Swansea Valley through No1 Main Pit to Dulais Valley - Note Mynydd Drumau study area is on West side of Duffryn Fault (SWR1681 4 of 5, 1914)

The section presented as **Figure 13** also illustrates that as the seams approach the Dyffryn Fault, they are folded down to the east. Such “drag-folding” is often associated with large faults like this. As the Skewen Level/Drummau Road Drift runs close to the Dyffryn Fault, it is expected that it lies in this drag-folded zone for most or all of its length. Although this section also shows several coal seams below the Maesmelyn seam, these are below Ordnance Datum (sea level), and thus are too low to be of relevance for this study.
