The Coal
Authority

MYNYDD DRUMAU – HYDROGEOLOGICAL CONCEPTUALISATION

**As related to the Skewen mine water
outburst January 2021**

November 2021

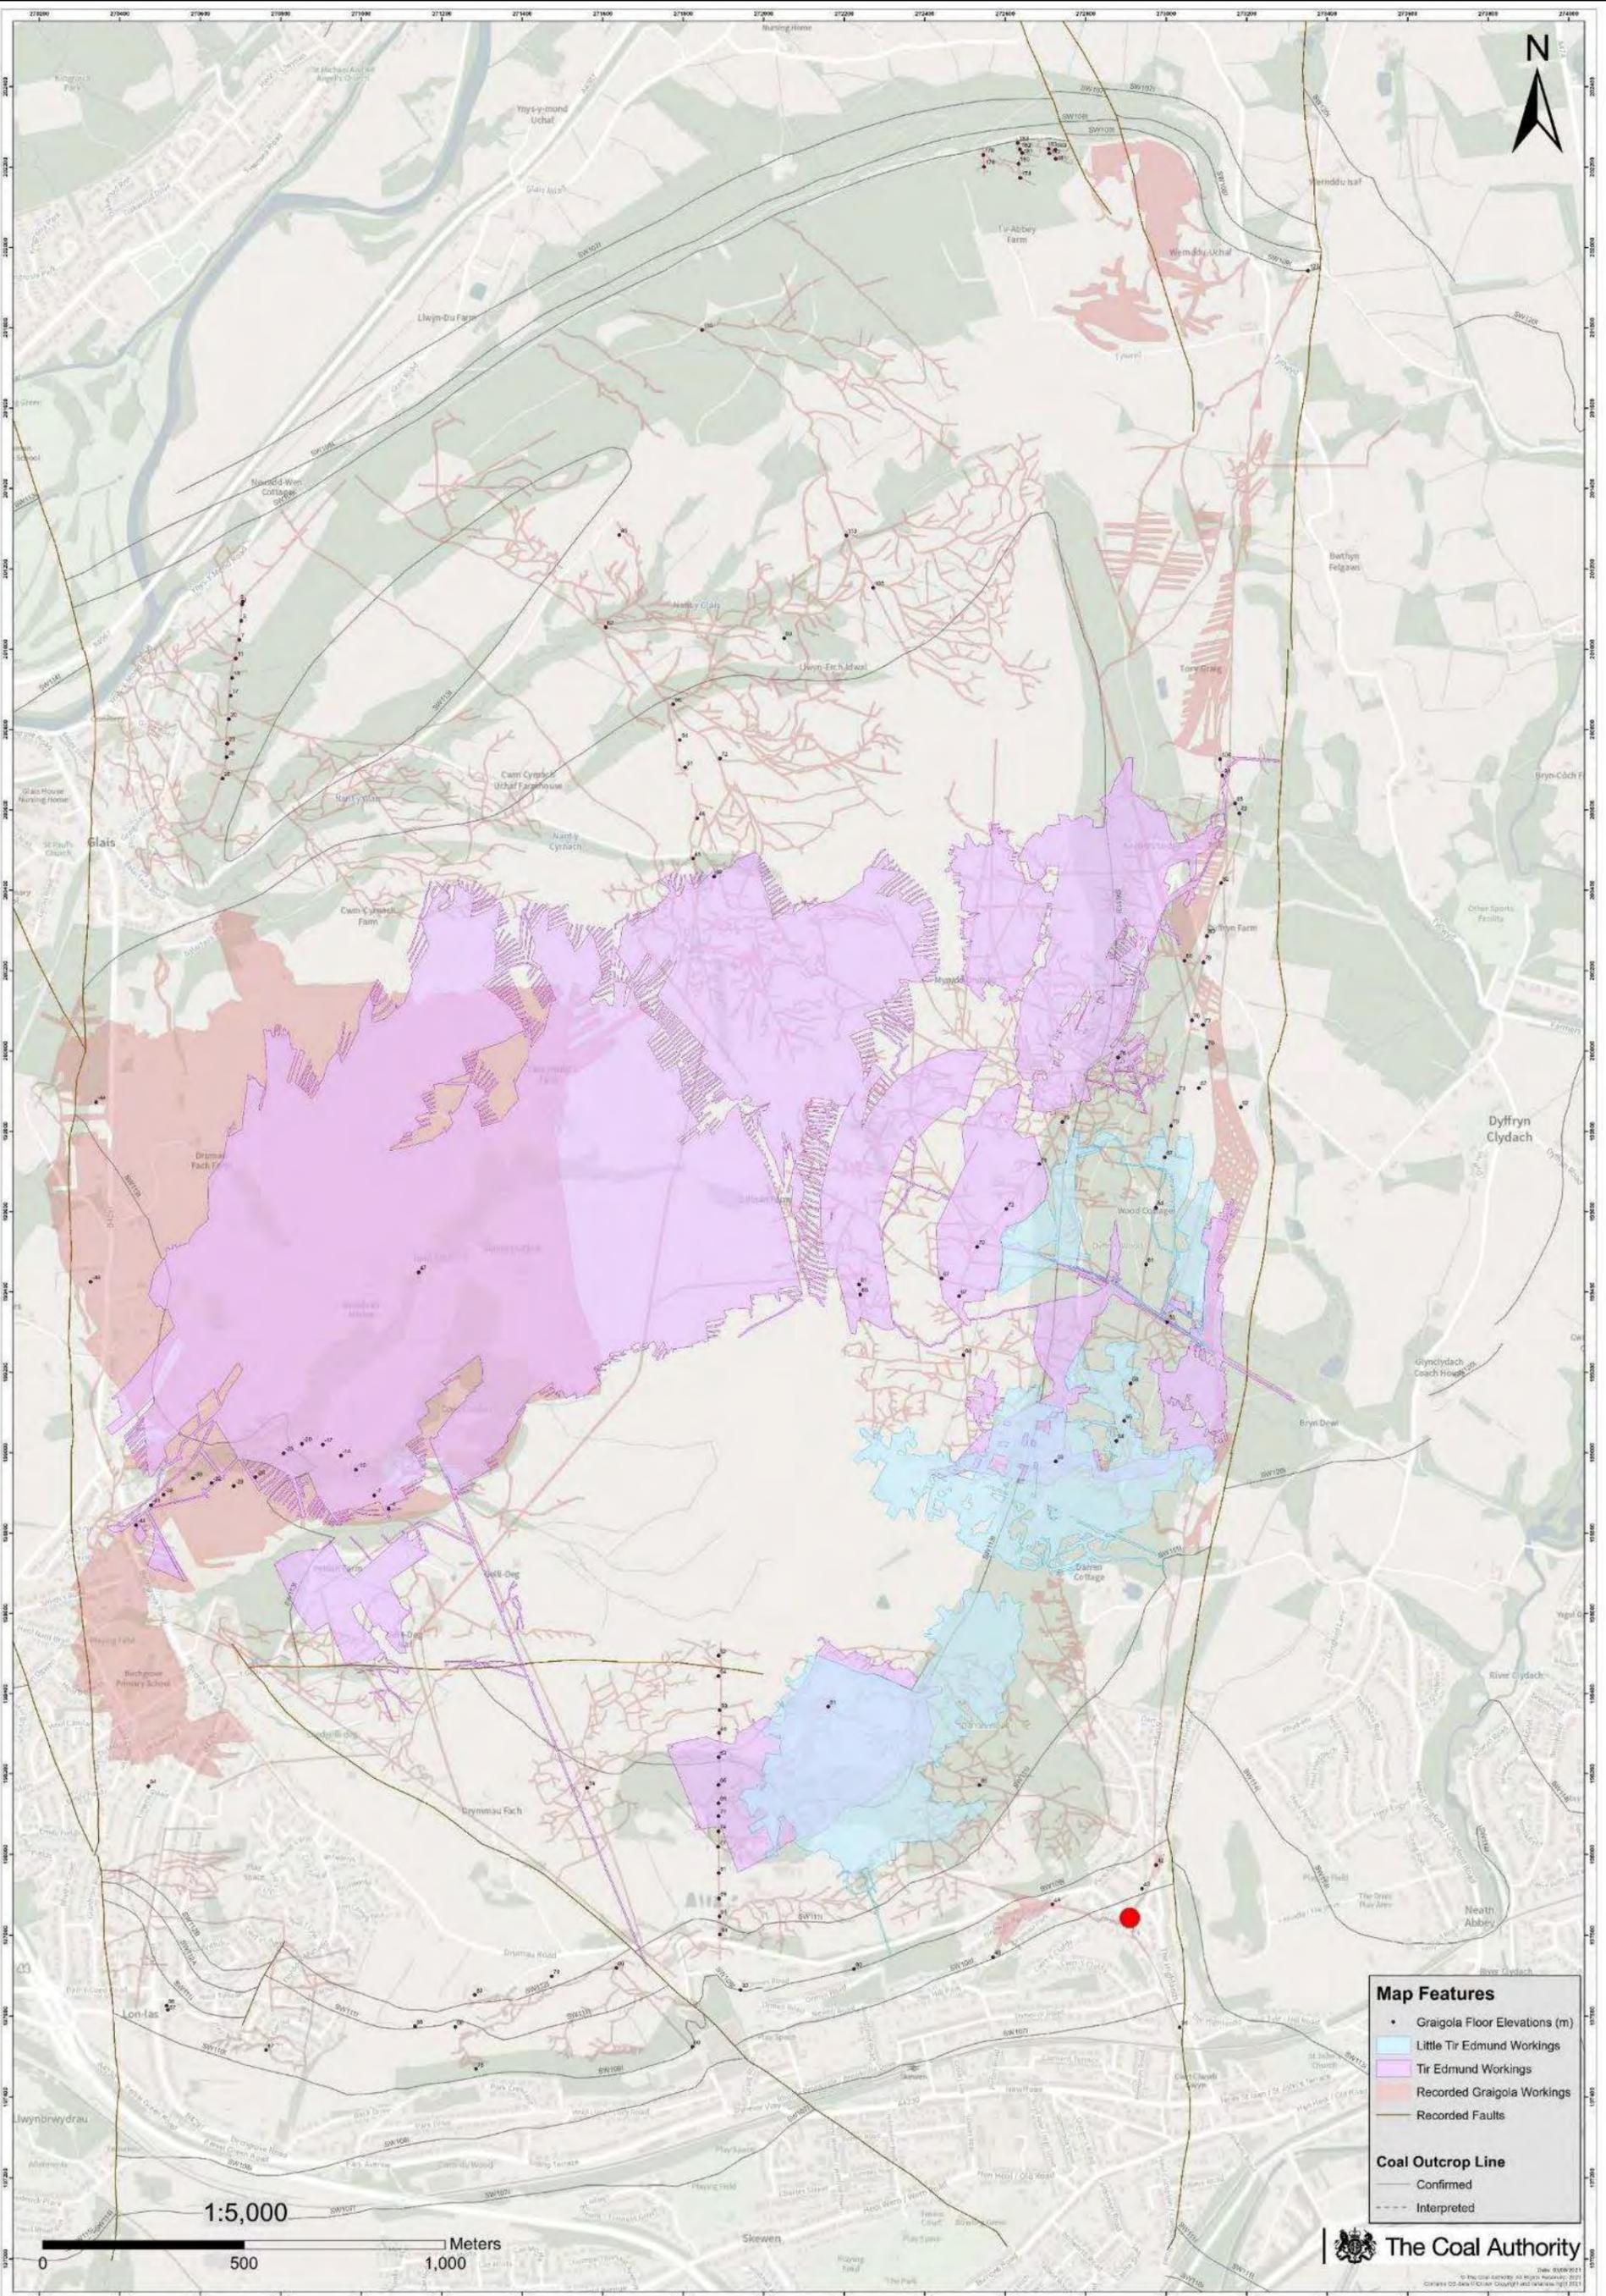
Figure 14: Overview of recorded workings in the Mynydd Drumau study area

- Notes:
- Area of recorded workings is based on measurement of digitised abandonment plans
 - Potential void volume is based on the minimum recorded seam thickness and assumes no loss of void through collapse
 - Working elevations are based on the highest and lowest areas of recorded workings
 - Potential discharge volume based on the area of workings at an elevation greater than the Skewen Level/Drummau Road Drift
 - Approximate vertical interval between seams - Little Tir Edmund is approx. 3 m above Tir Edmund, Tir Edmund is approximately 25-30 m above Graigola.

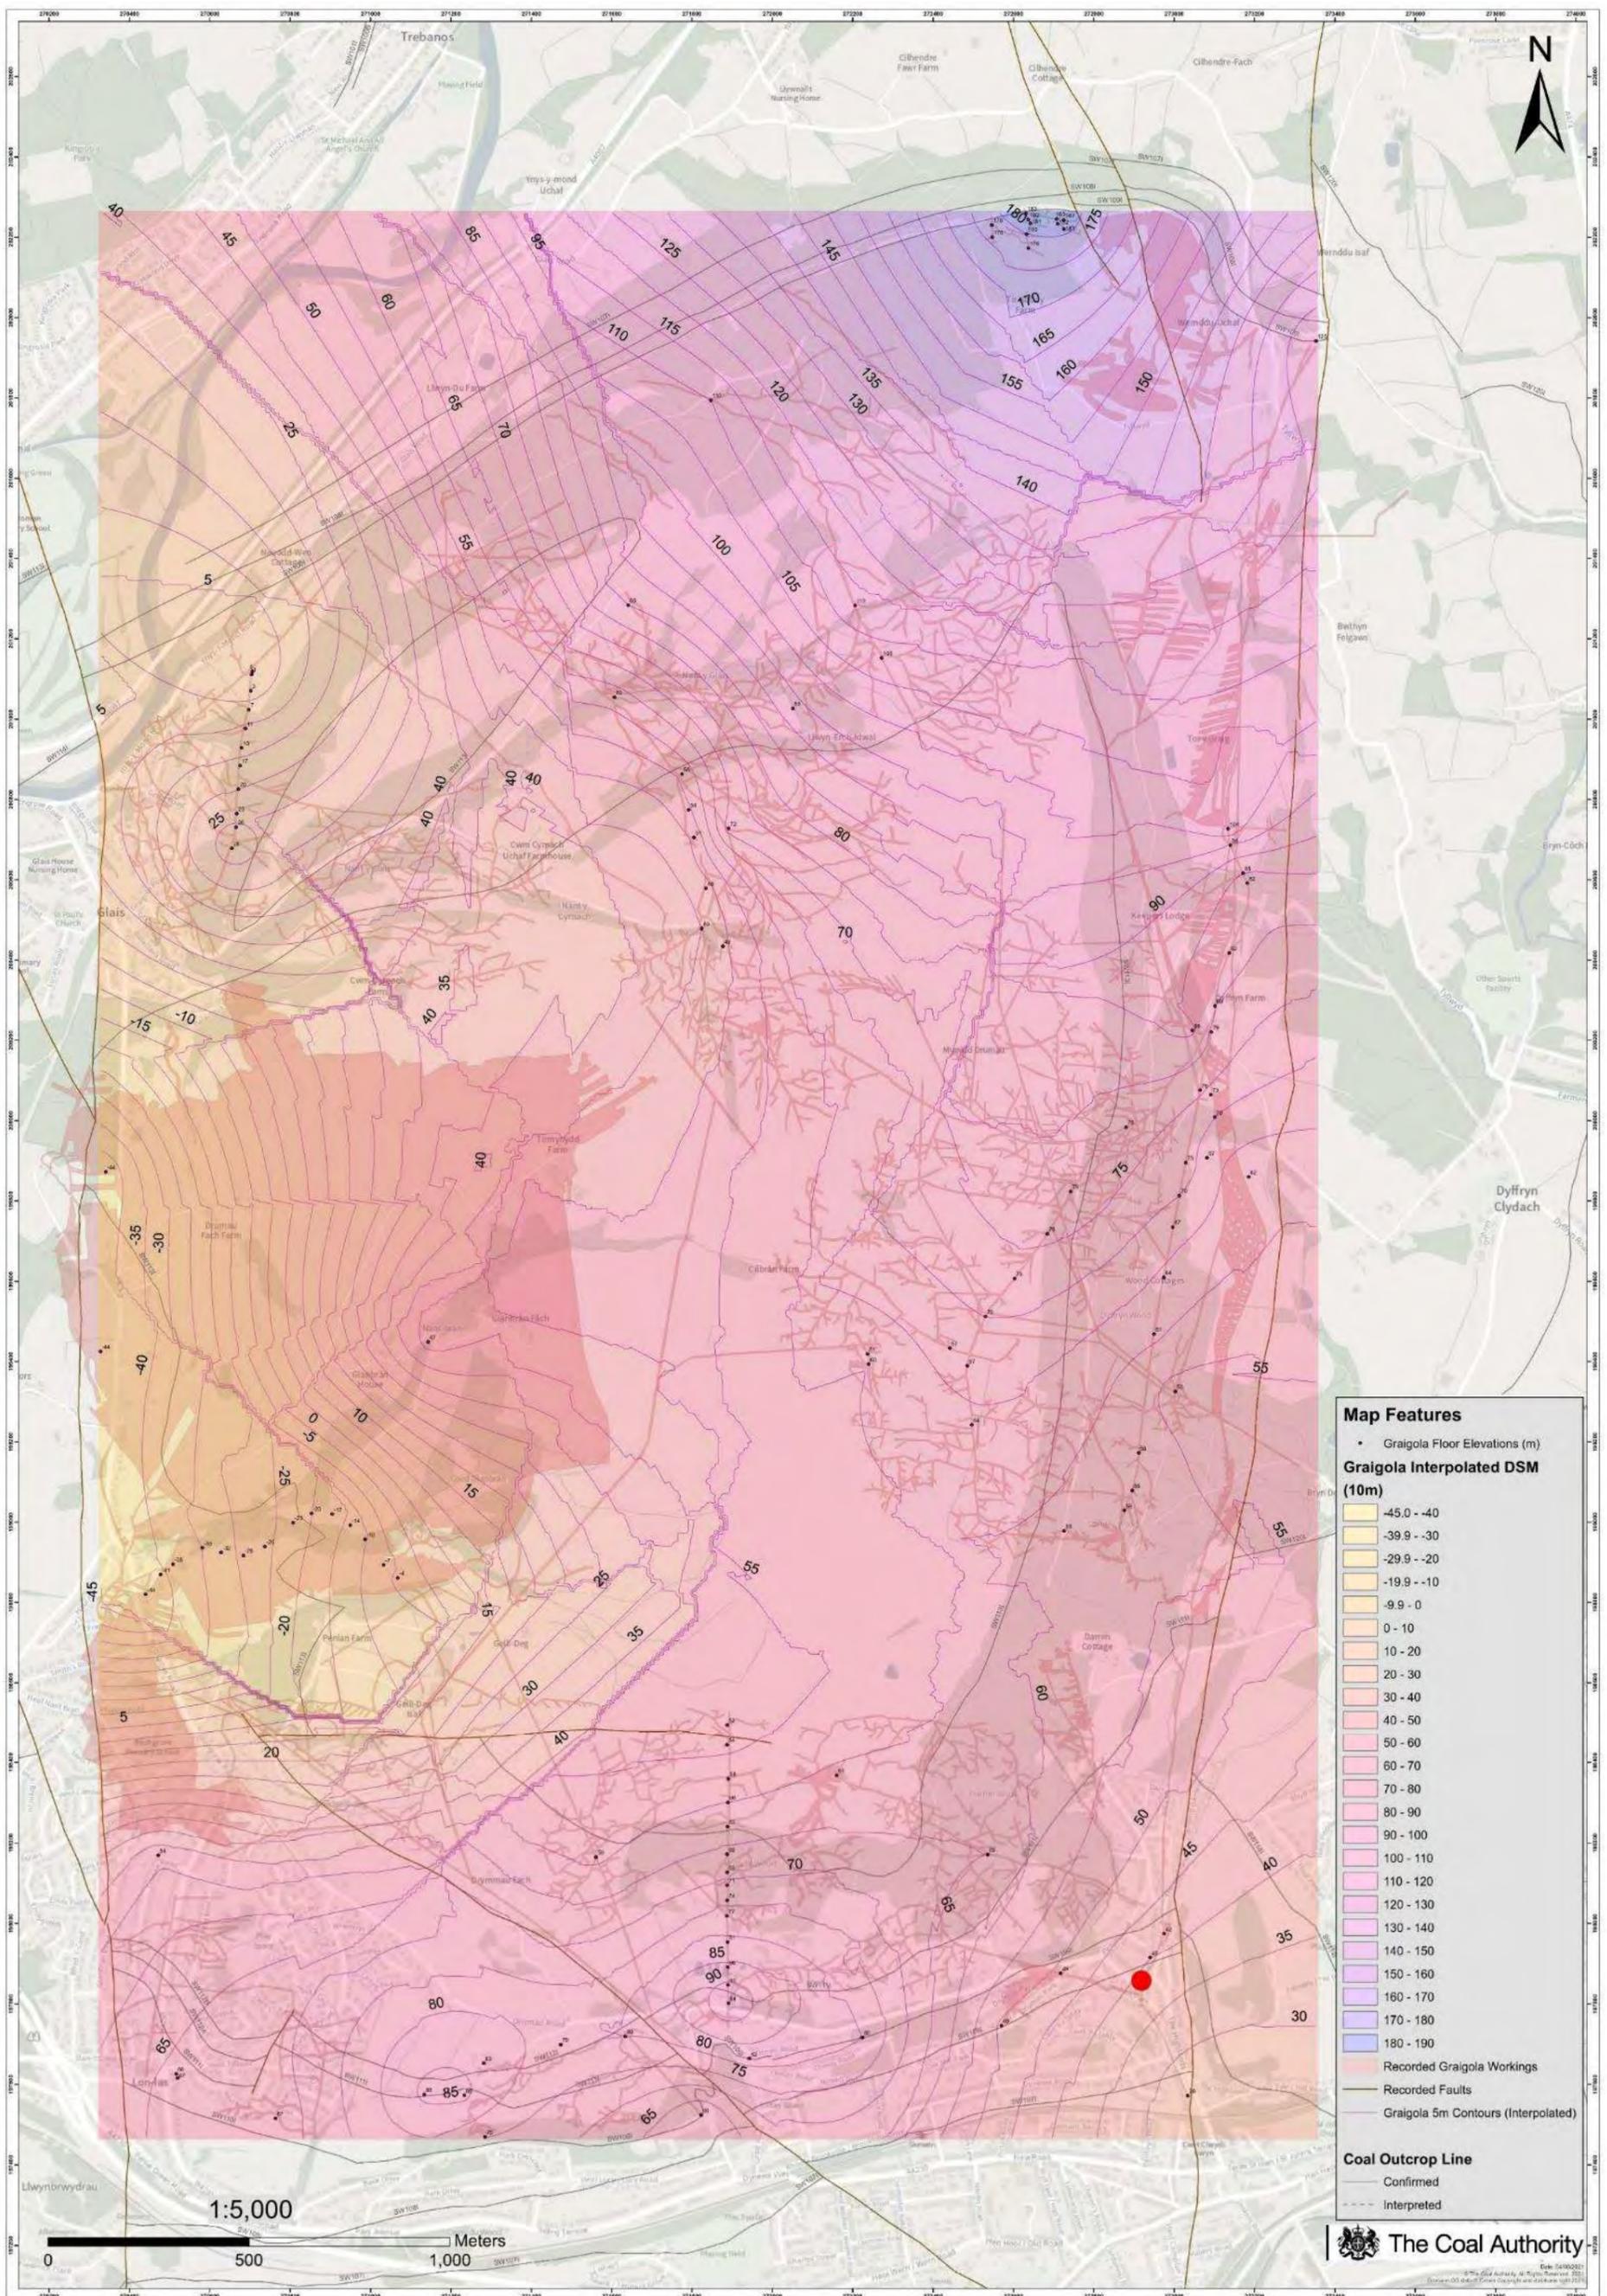
Figure 16: Graigola seam elevations contours in the Mynydd Drumau study area

The full mining block area is 12 km², the western portion of the block has an area of 9 km² whilst approximately 3 km² drains toward the Skewen Level/Drummau Road Drift. The interpreted limit of the eastern area draining to the Skewen Level/Drummau Road Drift is included in **Figure 17**. Modelling of the Graigola workings from the abandonment plans shows that the lowest point of the groundwater divide has an elevation of between 60 and 65 mAOD, with the best estimate being 63 mAOD.

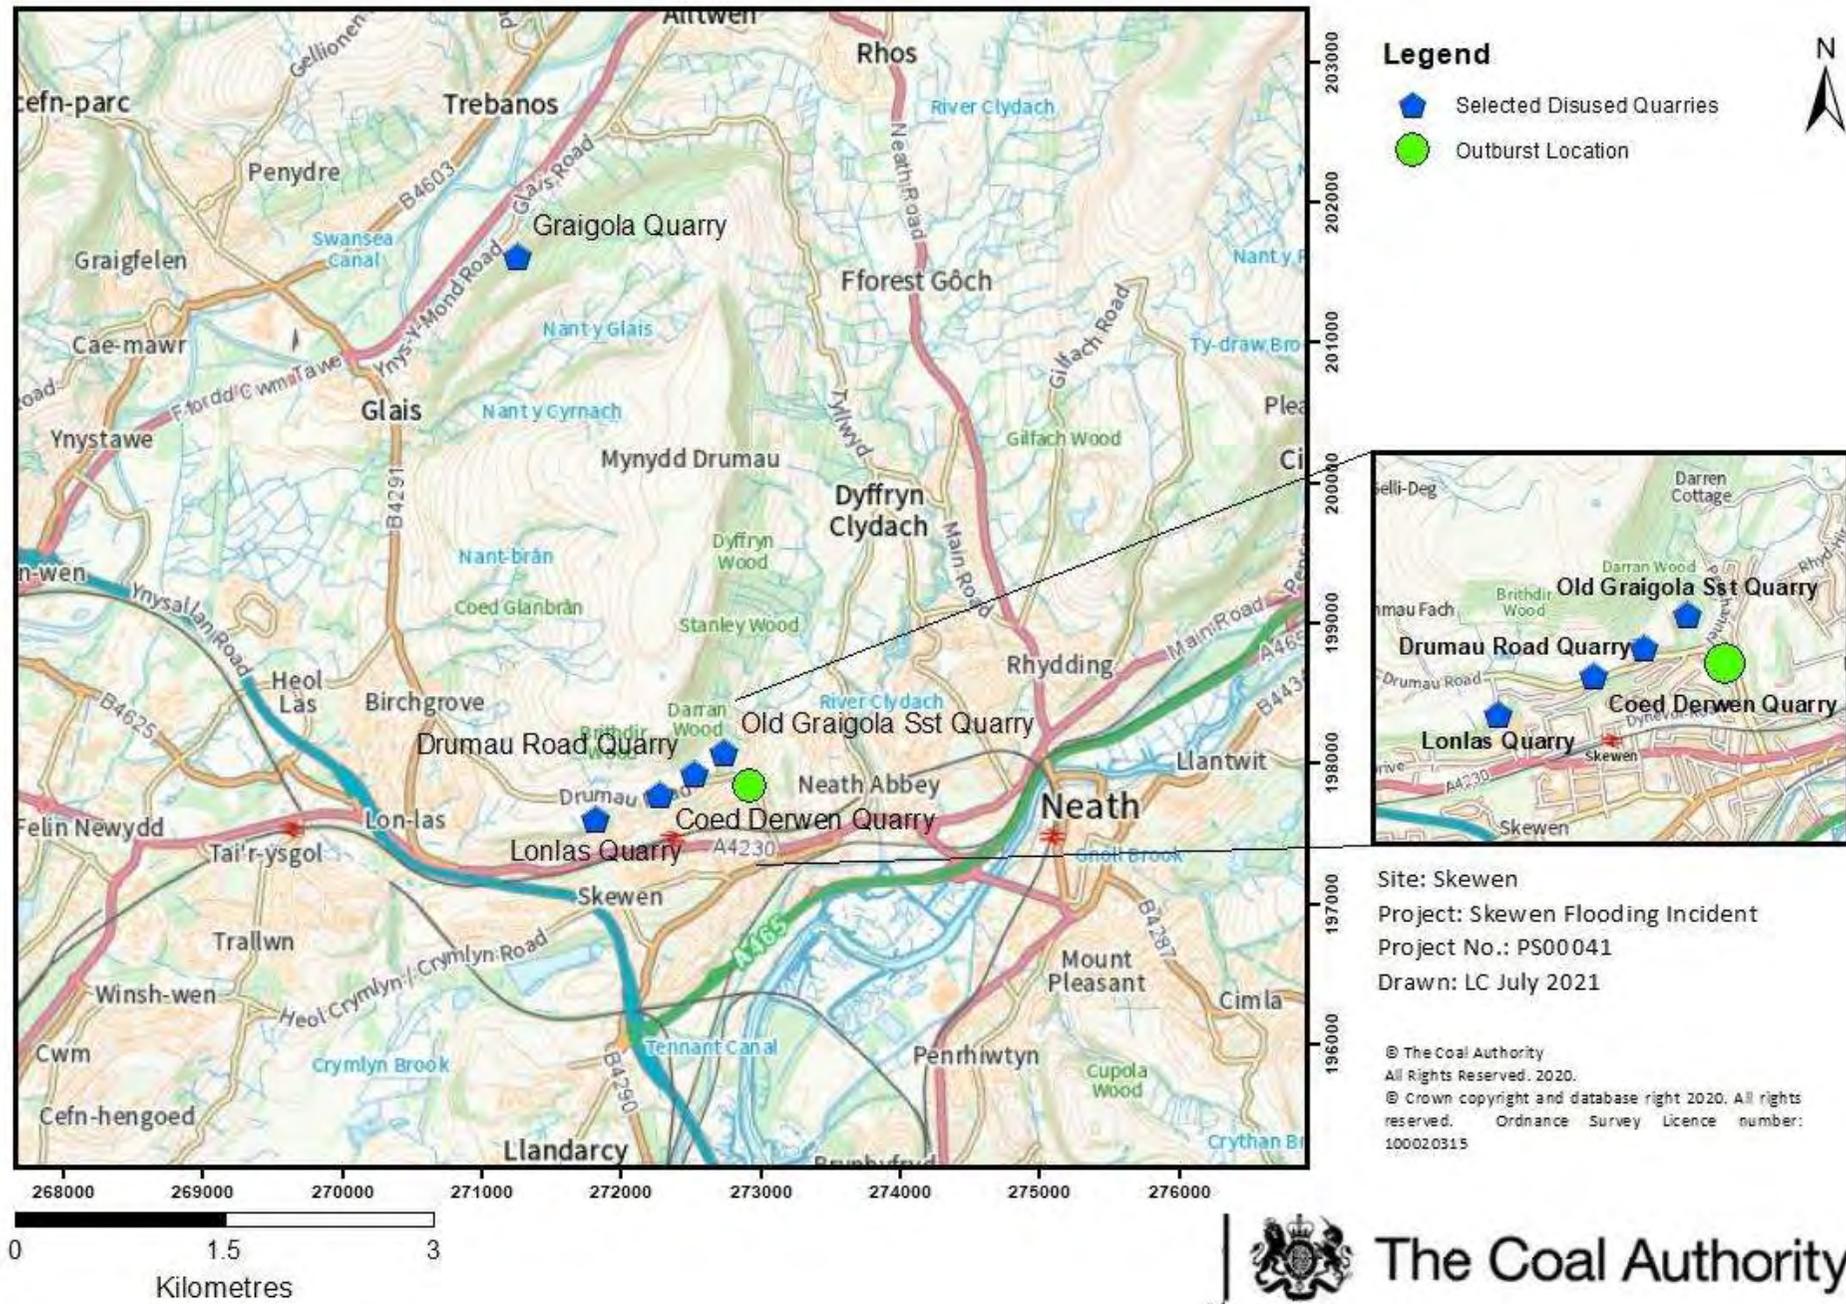
Figure 18: Disused quarries inspected by Coal Authority

Graigola Quarry	271260	201620	85	<ul style="list-style-type: none"> • Exposure of jointed Graigola Sandstone • Mine entry at the foot of the high wall with water on floor • mine entry is likely to act as an inflow pathway • Recharge at this location would feed the western sub block

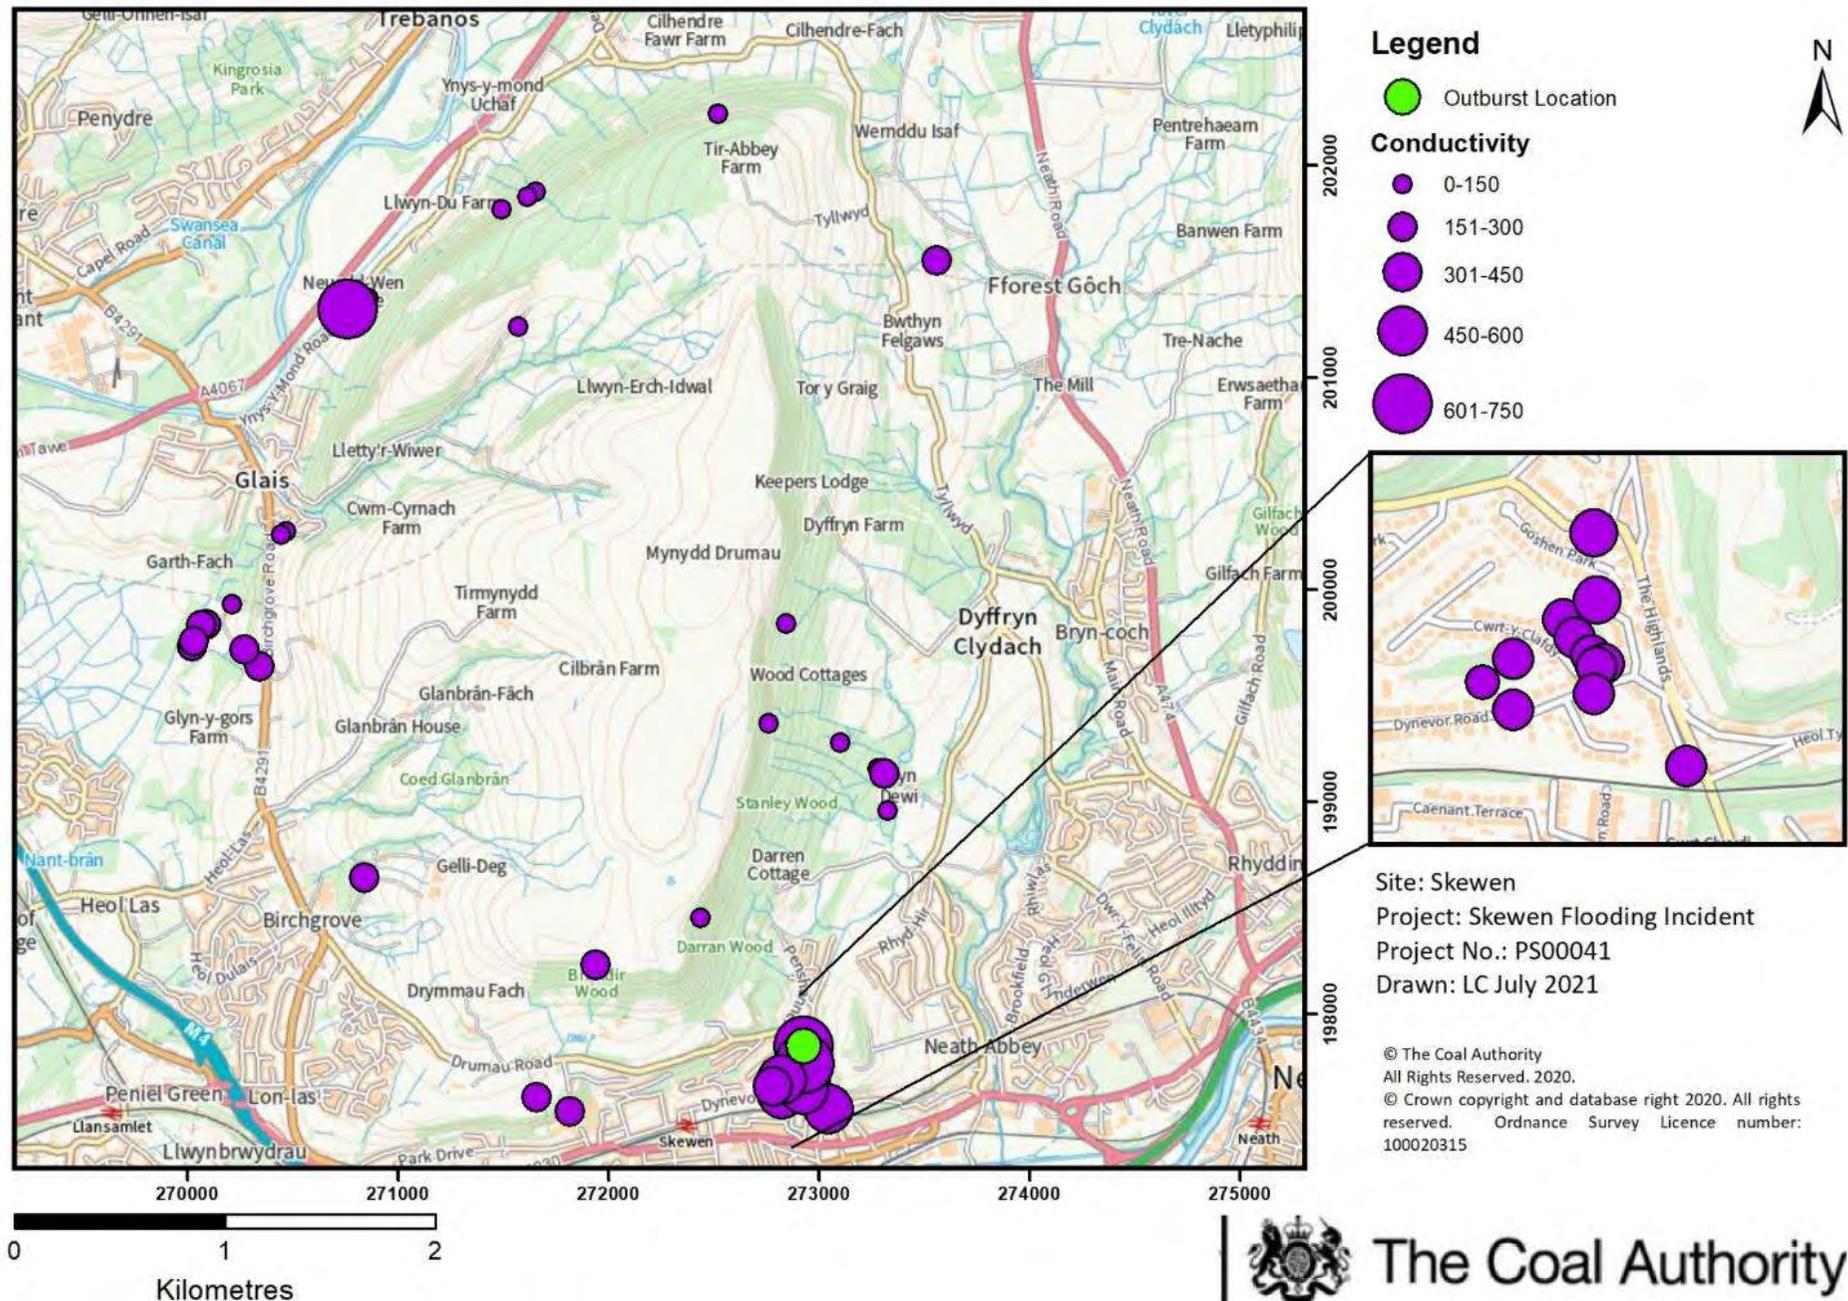
Figure 20: Discharges and measured electrical conductivity ($\mu\text{s}/\text{cm}$) across Mynydd Drumau study area

The consistently high mineralisation (EC and TDS values) of the discharges tested around the village of Skewen suggests that they are from a source similar to the main Graigola discharges (the Goshen Park outburst discharge, Drummau Road Drift, and Neuadd Wen). Some minor differences between the Skewen discharges and the Graigola water may be attributable to local mixing with lower electrical conductivity shallow groundwater.

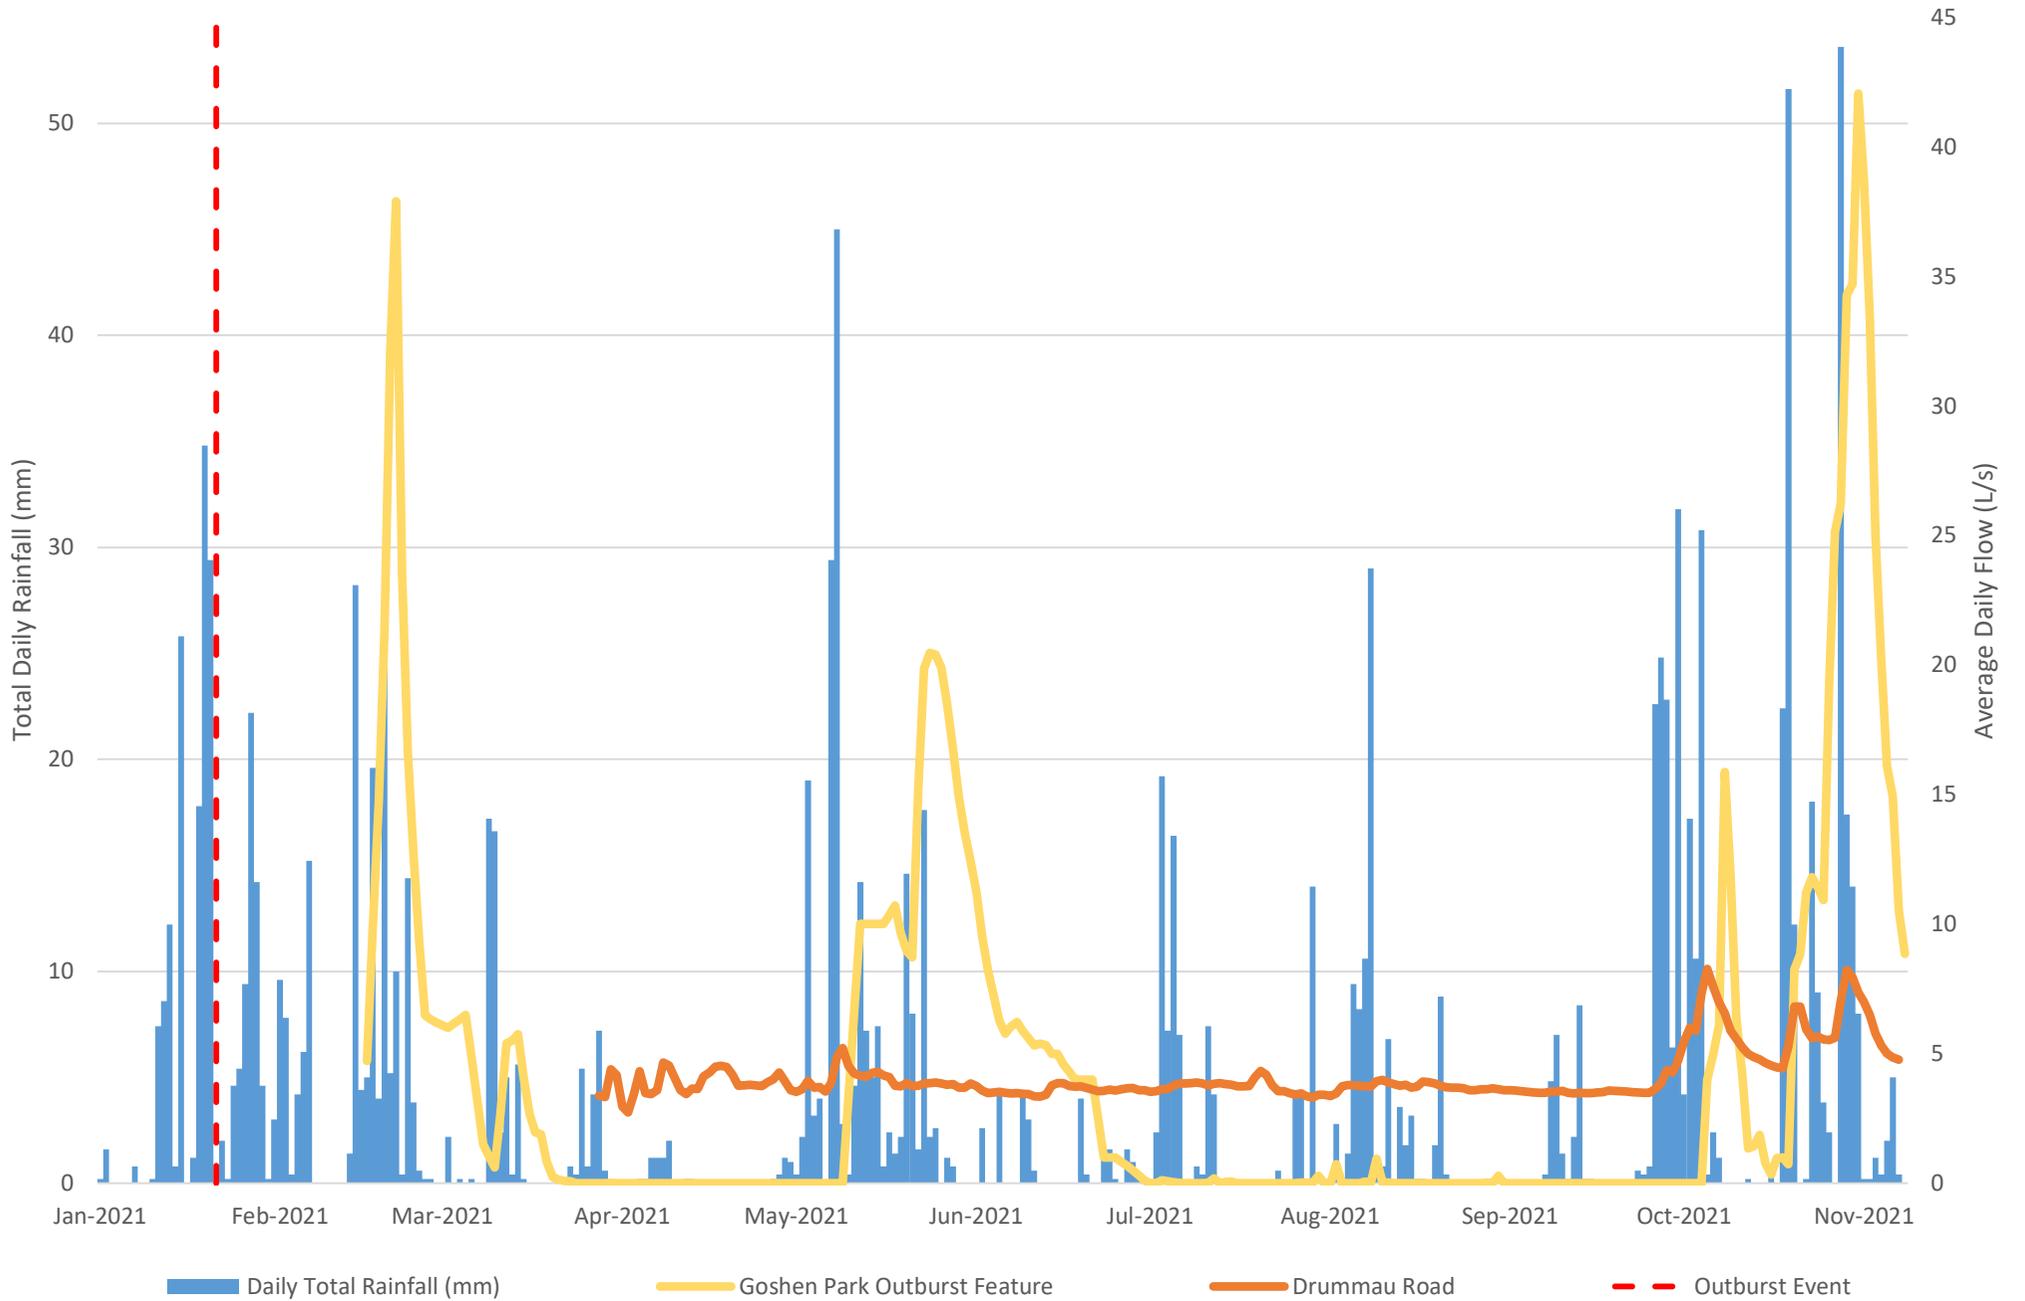
Figure 21: Goshen Park and Skewen Level/Drummau Road Drift Flow and daily rain (Birchgrove Main)

During the monitoring period, the water level in the Goshen Park outburst feature was controlled by the level of the outflow point and only fluctuated slightly, with levels falling during sustained dry weather. This water level therefore meant that the driving head of mine water in the lower system remained relatively constant and therefore, fluctuations in flow seen are not thought likely to be driven by changes in hydraulic head.

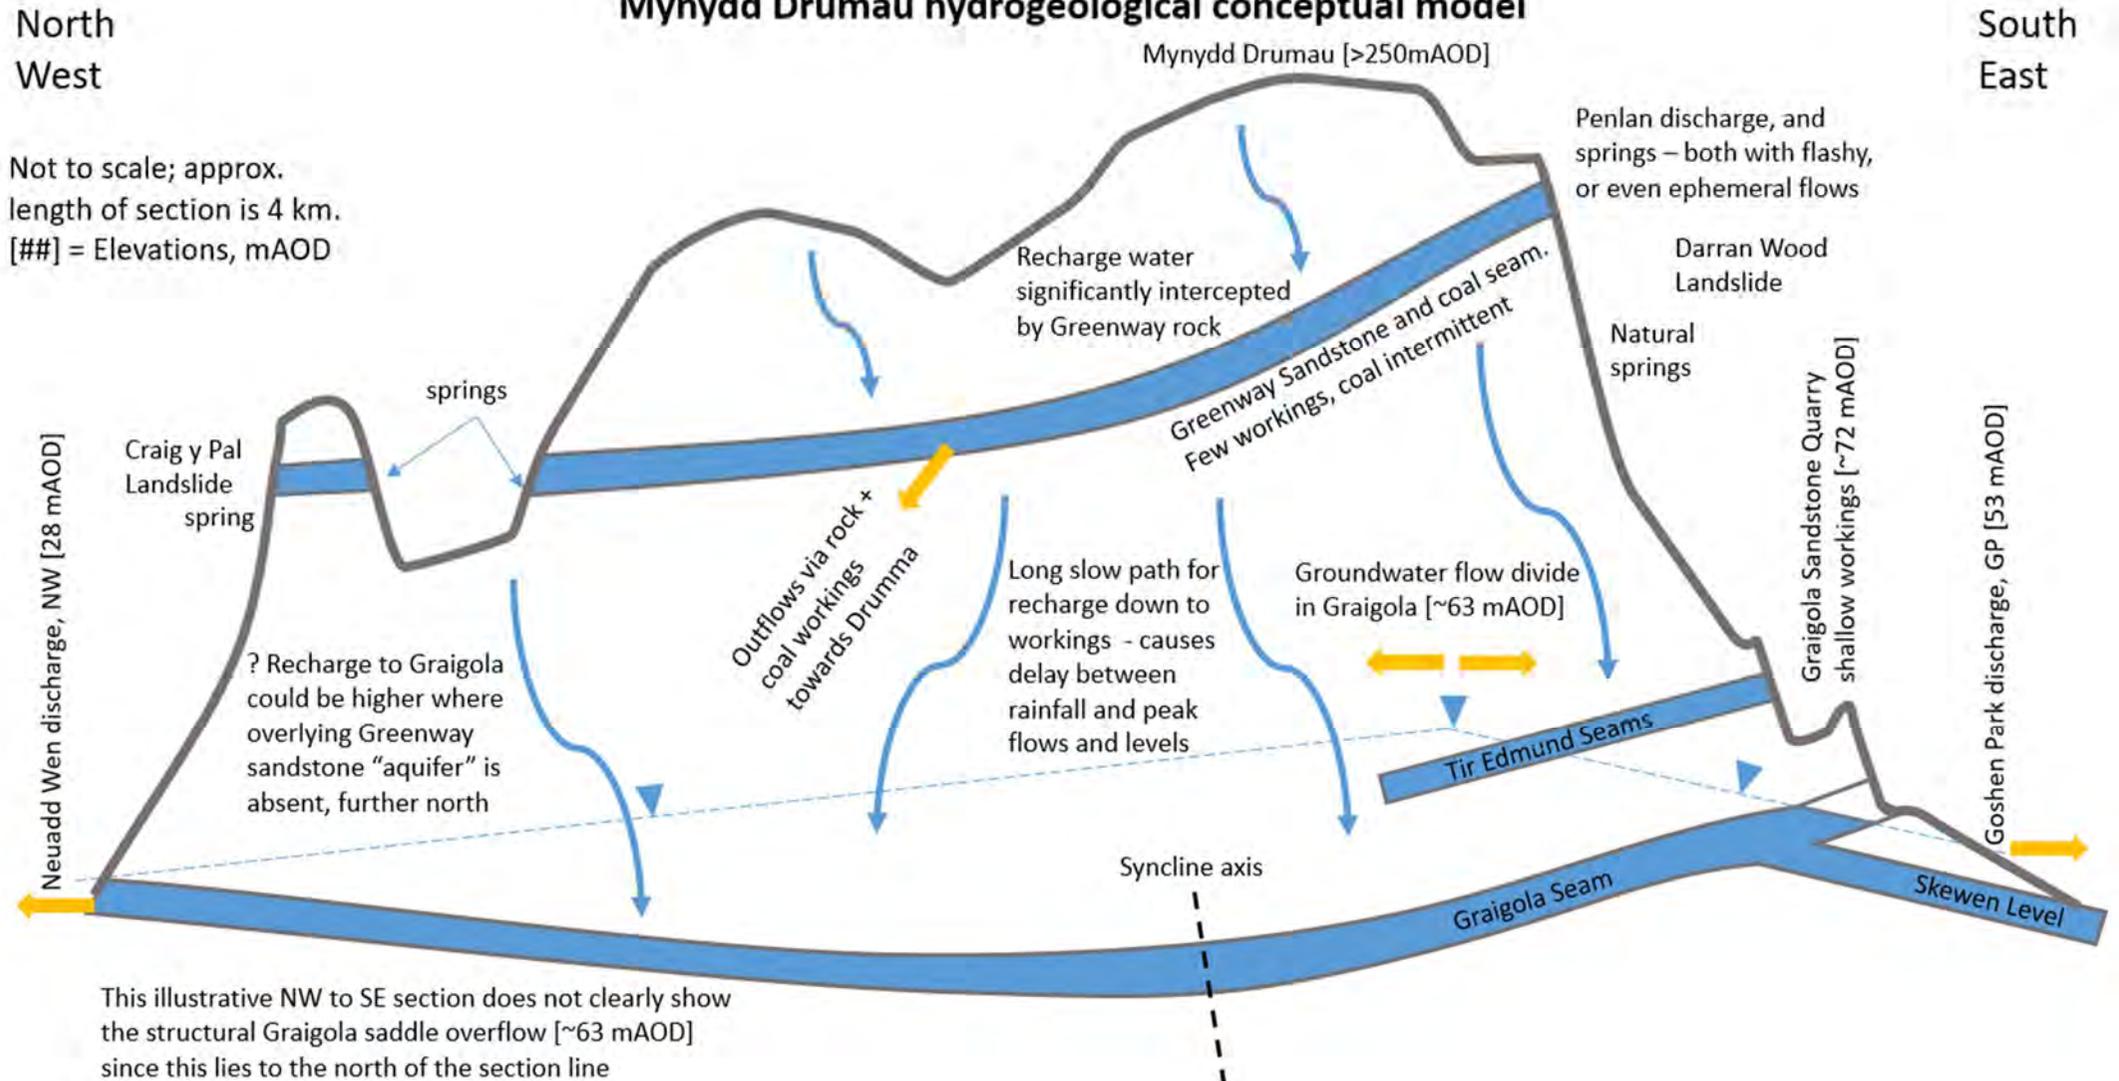
Figure 1: Mynydd Drumau mining block hydrogeological conceptual model

Mynydd Drumau hydrogeological conceptual model

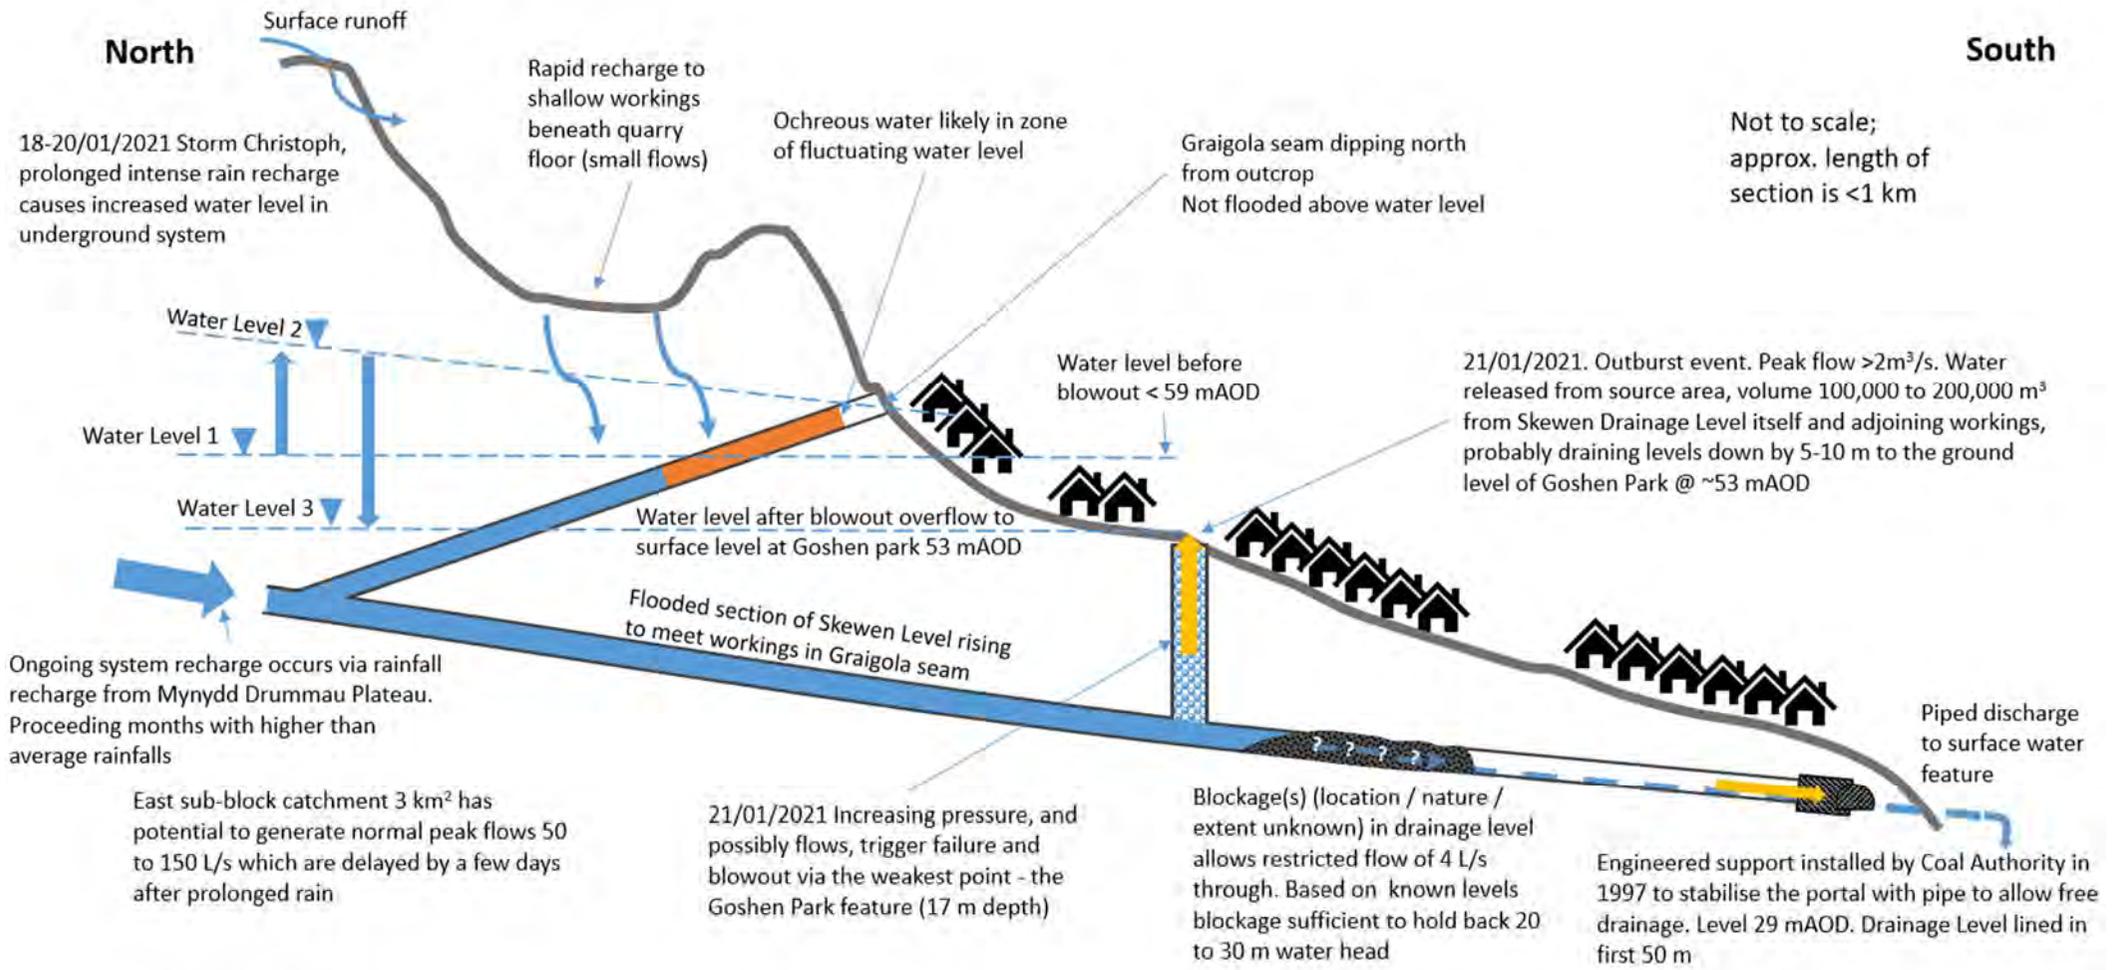
Figure 23: Skewen Level/Drummau Road Drift outburst site conceptualisation B - local release

Although this combined model scenario seems to provide the best fit with the evidence, there remains high uncertainty with the interpretation.

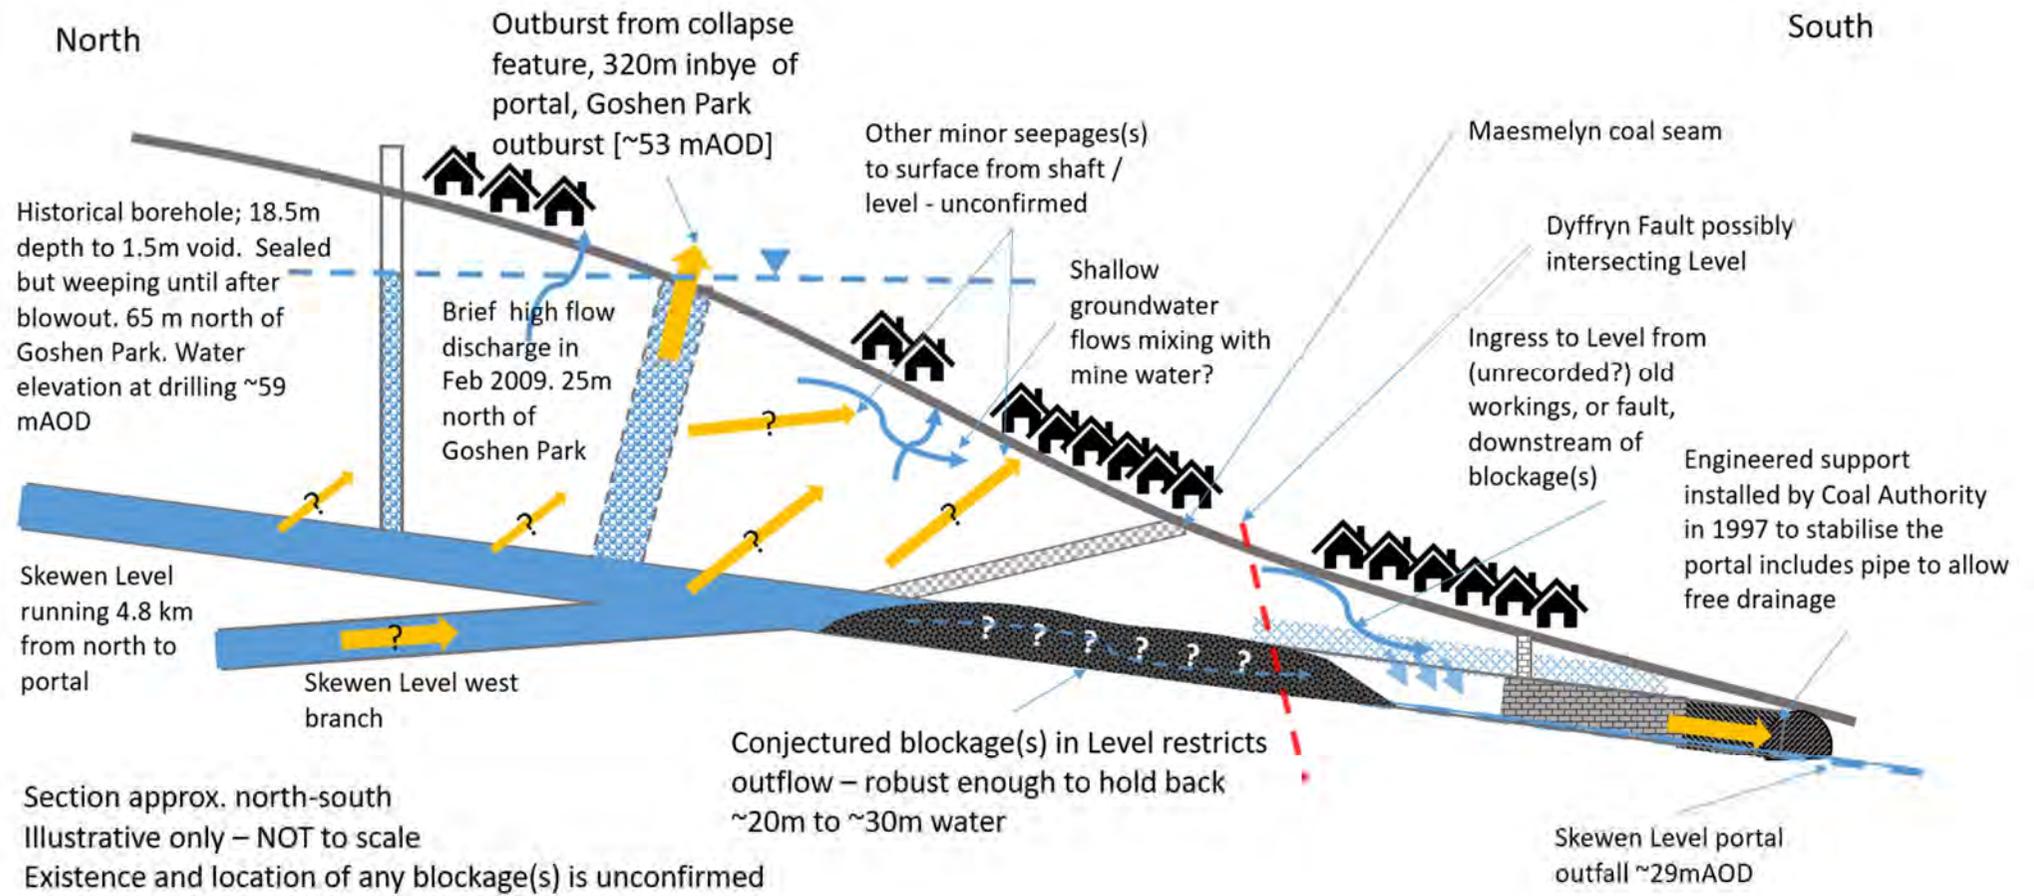
Figure 24: Skewen Level/Drummau Road Drift outburst site conceptualisation for local hydrogeological processes

The blockage may transmit some water from the inbye system, as seen at the portal outflow though this could comprise water made from the level outbye of the blockage. It is also noted that due to the head in the system to the north of the blockage it is possible that water related to the mining system could be encountered in the subsurface around Skewen at points with an elevation below 53 mAOD. The flow monitoring at this location since the outburst is comparable to the historical flow data, indicating little has changed in the system governing this flow since the outburst event.
