The Coal
Authority

MYNYDD DRUMAU – HYDROGEOLOGICAL CONCEPTUALISATION

**As related to the Skewen mine water
outburst January 2021**

November 2021

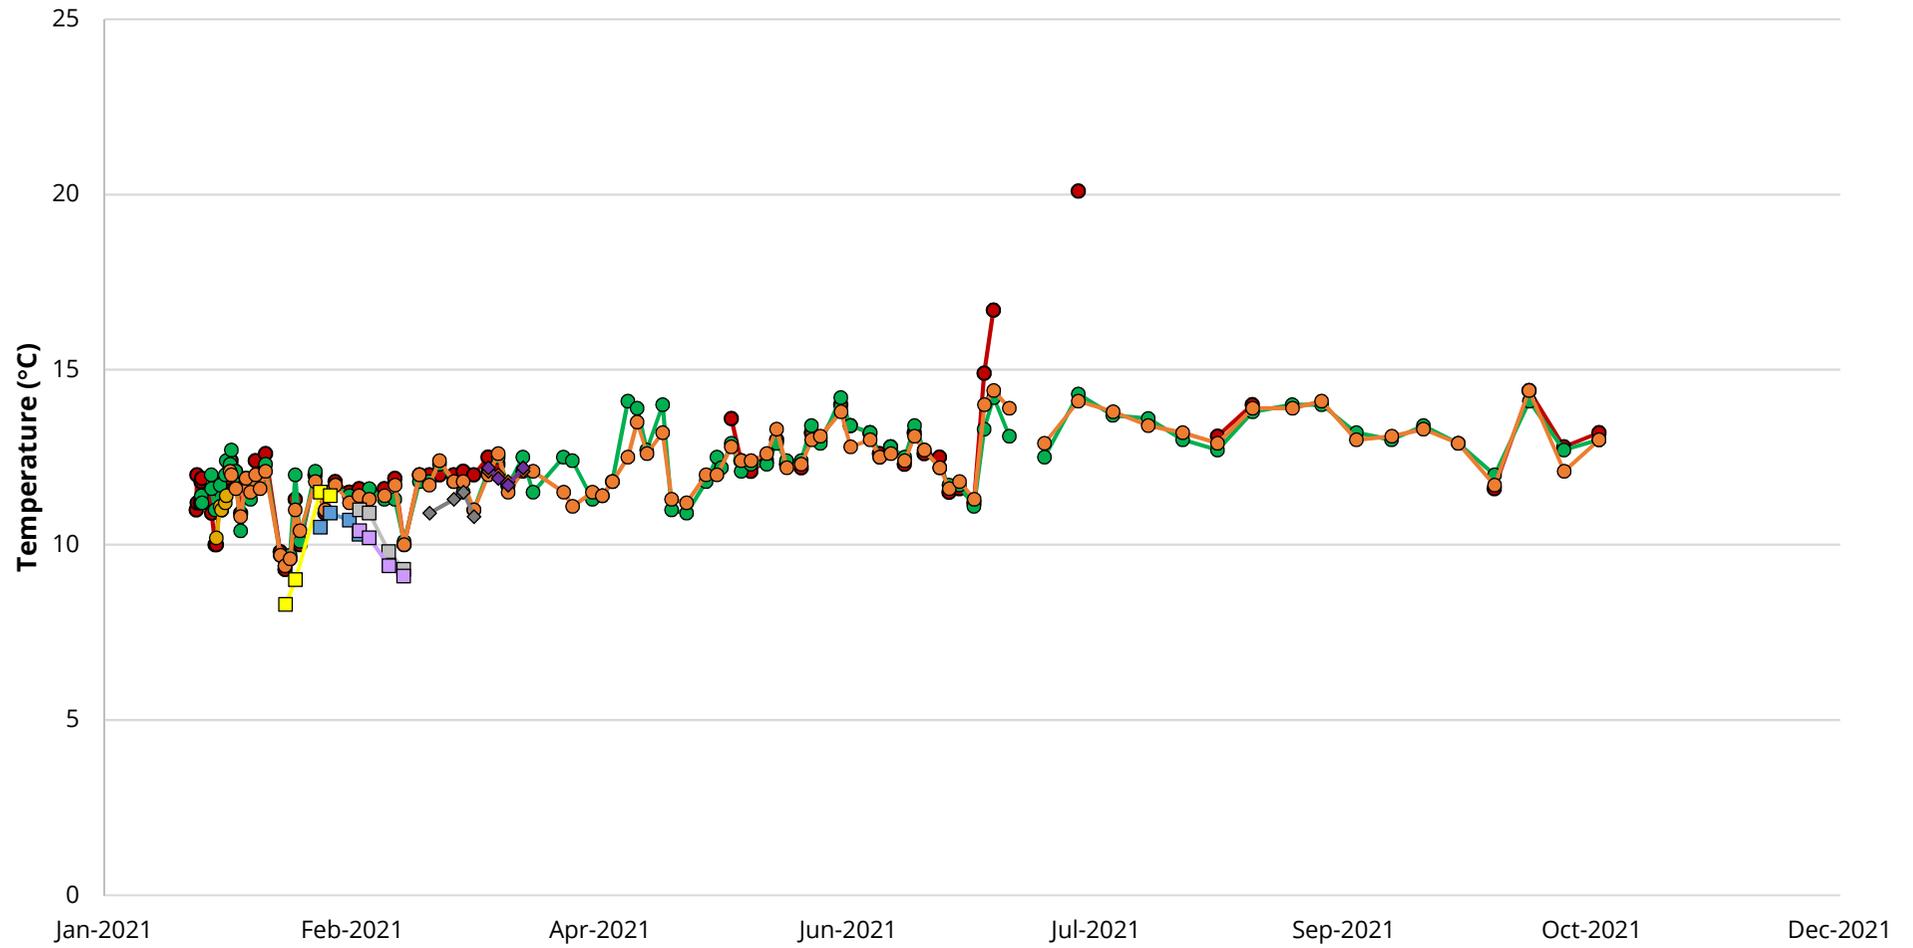
Mynydd Drumau : Water Temperature

- Goshen Park
- Drummau Drift
- ◇ 70 Cwrt y Clafdy
- 87 Dynevor Road
- Bryndewy Level
- Lonlas Old Graigola
- Drumma Greenway Level
- Neuadd Wen Graigola
- ▲ 9 Sunnyland Crescent
- ▲ 73 Cwrt y Clafdy
- ▲ 75 Cwrt y Clafdy
- ▲ 32 Jubilee Crescent
- ◇ 77 Dynevor Road
- ◇ Woodlands East
- ◇ Woodlands West
- ◇ Borehole 10
